Sediment quality assessment by Sediment Profile Imaging (SPI) in contaminated Norwegian harbour and fjords

Hans C Nilsson

Norwegian Institute for Water Research (NIVA), Gaustadalleén 21, NO-0349 Oslo, Norway

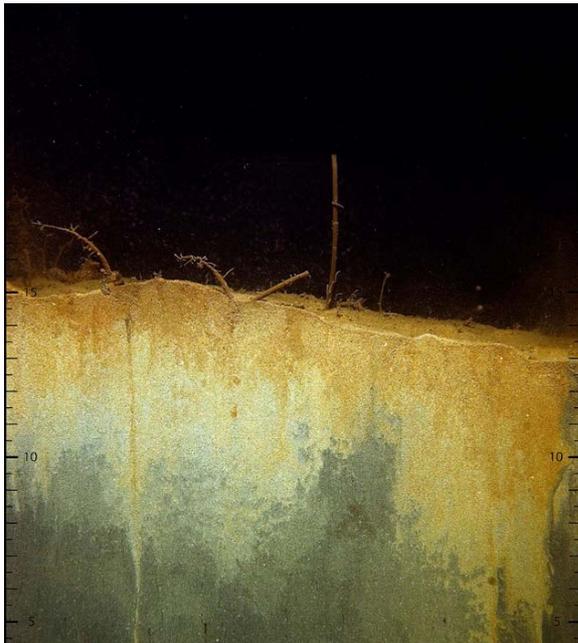
Fig. 1: A sediment profile image (SPI) from one of the most heavily polluted area in the Grenlandfjord area (Frierfjord). However, ecological the area is healthy with a rich benthic fauna.

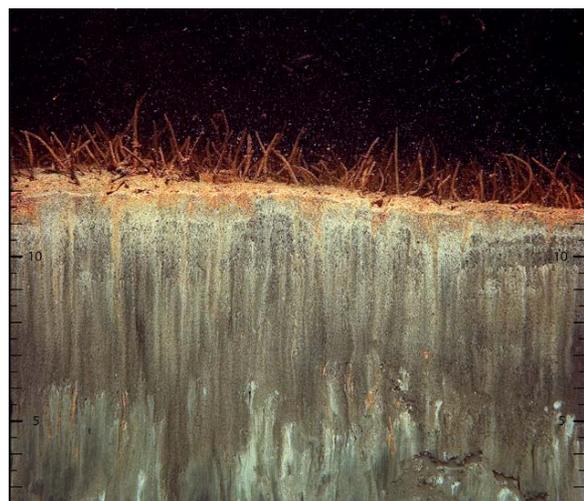
Results: In organic enriched sediments in Oslo harbour the benthic habitat quality increased rapidly and was already recolonized by tube building polychaets 6 month after remediation. In Kristiansand harbour the SPI survey showed an incomplete cover of the cap, with less successful remediation of the sediment as consequence.

Fig. 2: SPI image from the Oslo harbour area. The sediment surface is recolonized of small tube building polychaet after a capping.
