Capping of contaminated seabed in Norway – lessons learned

Jens Laugesen, DNV GL, Høvik, Norway

Espen Eek, NGI, Oslo, Norway

14.06.2017

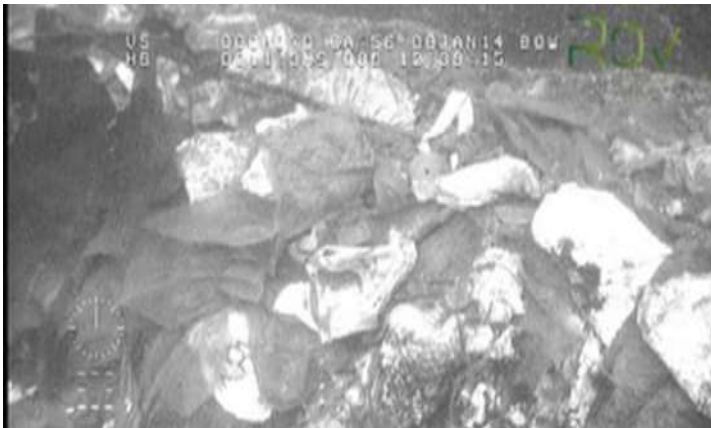
Example Kollevågen Bergen – Lack of stability

- In Kollevågen outside Bergen municipal waste was placed in the shoreline and in the sea in the period between 1930-1975.
 - In 2005 the municipal waste was covered with a 0.5 m thick layer of rock material (grain size: 0-32 mm) followed by a geotextile and a 0.3 m thick erosion protection layer (grain size: 0-64 mm).
- Investigations in 2012 and 2014 done by NGI showed that the cap was damaged and that the waste that was below sea level was exposed at several locations.
- The most probable reason for this was that the cap did not have sufficient stability with respect to erosion, slope stability and/or uneven settlements in the waste.

Exposed waste due to damaged cap at Kollevågen (NGI, 2014)

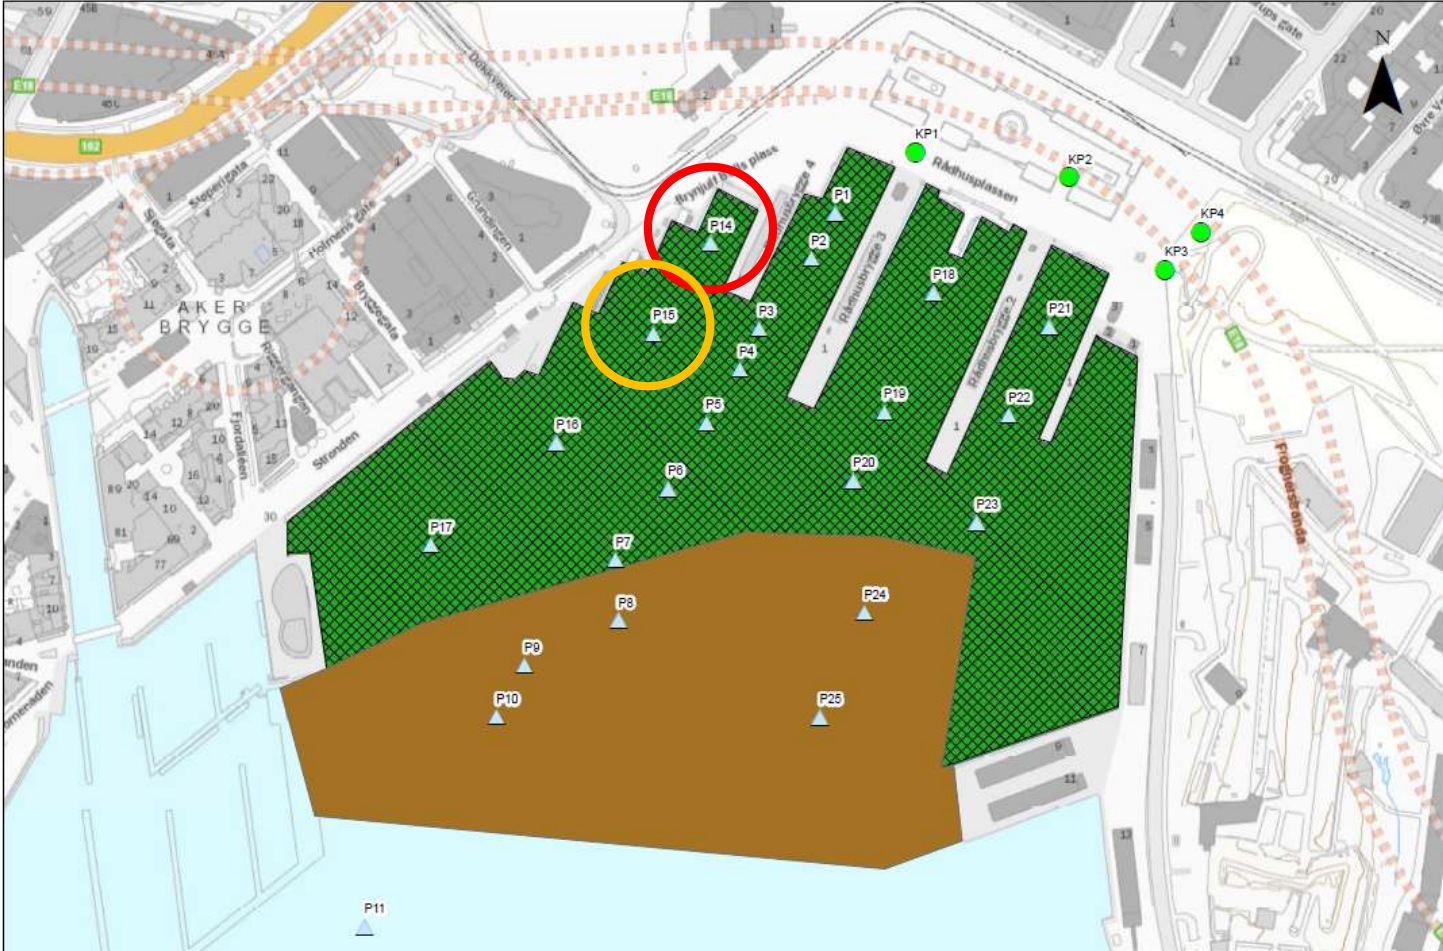
Example Oslo harbour – Erosion

Red circle: Area where all cap material was gone

Yellow circle: Area where the cap still was left (but with very reduced amount of fines).

- In this case a relatively fine-grained cap had been washed away from a smaller area where the seabed was exposed for a substantial propwash. The exposed seabed was, however, clean.
- In adjacent areas the cap is still intact.
- The example shows that a cap has to be designed to withstand propwash in areas with ship traffic. It also shows that areas just outside the areas that are most exposed for erosion (propwash) can withstand erosion even if the ships are moving over this area also.

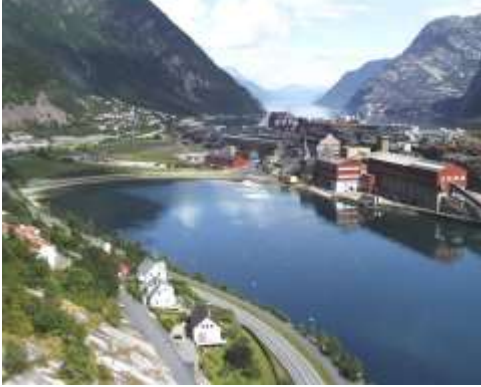
Long-term experience with capping – Eitrheim Bay

- The contaminated sediments in Eitrheim Bay were covered with a geotextile and capped with sand in 1992.
 - Surveys done by divers in 1995 showed that the cap was intact and there was substantial biological activity on the surface of the cap.
-

- A new diver survey and sampling of sediments in 2001 showed that the surface of the cap had been recontaminated by sources on land (NIVA 2002 and 2010).
 - An assessment done by DNV GL (2009) concluded that there were two probable main causes for the recontamination: accidental and regular discharges from local industries and waste disposals.
 - An assessement was done of the regular discharges (those that were included in discharge permits) which showed that they could cause substantial increase in the concentration of contaminants in the sediments (and the cap).

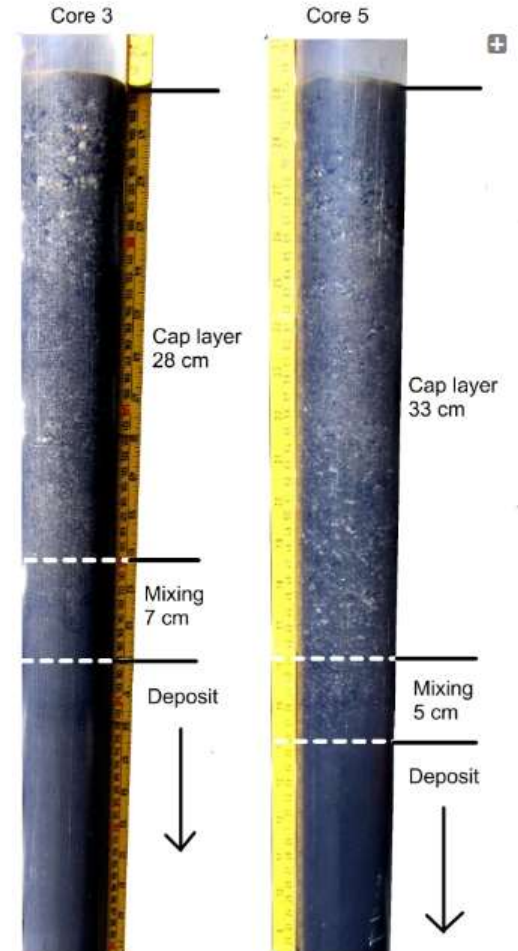
- One of the most investigated caps is the one that is covering the deepwater disposal at Malmøykalven in the Oslo fjord close to Oslo. The requirement in the permit was a 0.4 m capping layer. As a part of the follow-up the capped area was investigated with respect to grain size distribution.
- The results showed that grain size distribution in the cap corresponded to the original cap material and thereby concluding that the cap was intact (DNV, 2012).

Samples of the cap at Malmøykalven showing the thickness of the intact cap, the mixing layer and the contaminated material. Photo: Hanne Vidgren, UiT.
