5th International SedNet Conference,
27th-29th May 2008, Oslo, Norway

Dumped ammunition - an environmental problem for sediment management?

Jens Laugesen, Det Norske
Veritas

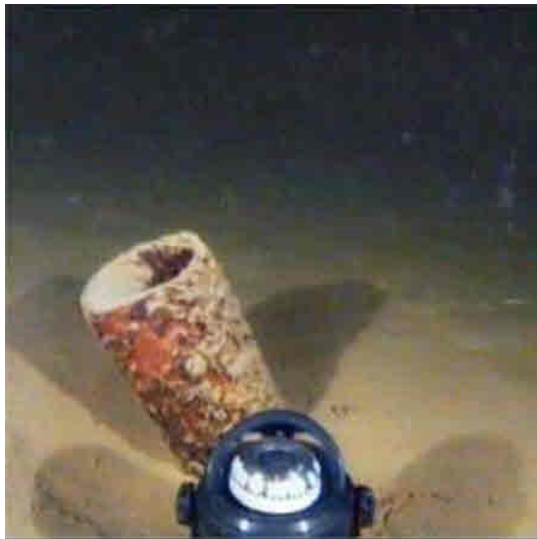
Shell (grenade) cap

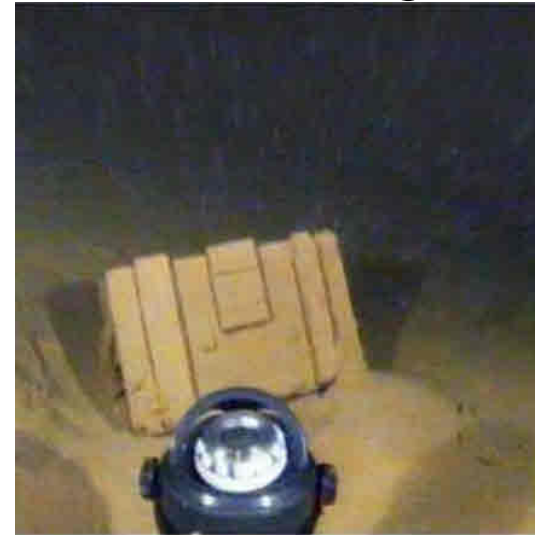
Ammunition box

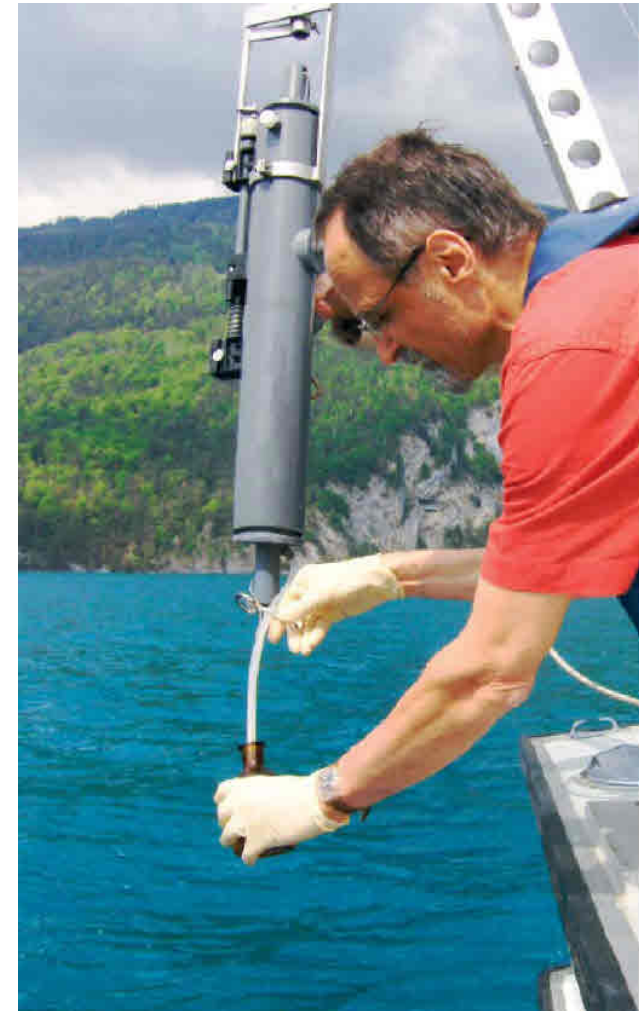
Water sampling for analyses of explosives (Lake of Thun)
