Risk assessment & management of polluted sediments in areas with a nautical necessity

A case study from the Port of Antwerp, Belgium

November
2013

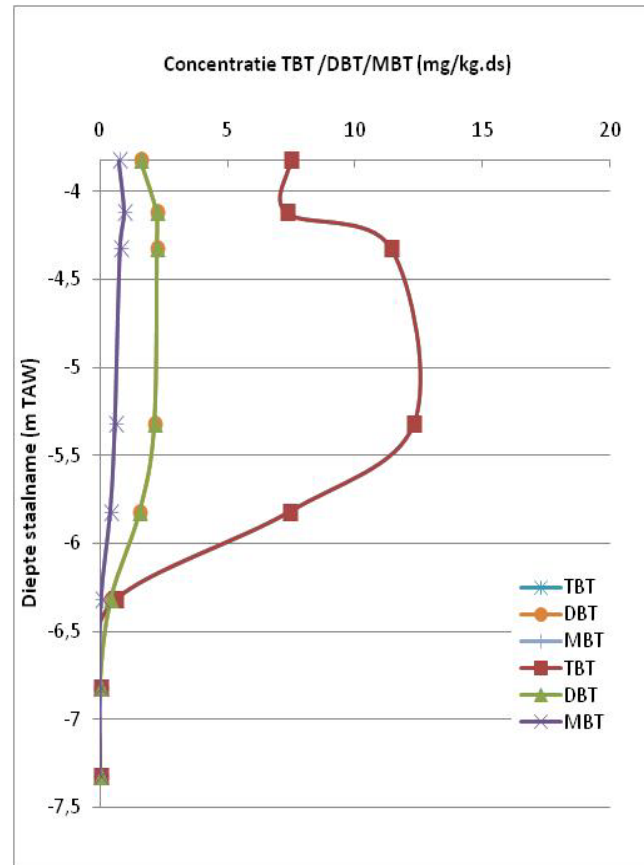
Gradient in concentration of TBT and MO:

- Project area for dredging works is polluted with heavy metals (Cu, Pb), mineral oil (MO), tributyltin (TBT), PCBs and naphthalene.
- The pollution with MO and TBT exceeds the scope of the dredging works by 200% (horizontally and vertically).
- No spreading from pollution on landside.
- Because of a remarkable gradient in concentration of MO and TBT in the docks, some additional samples and analysis were executed.

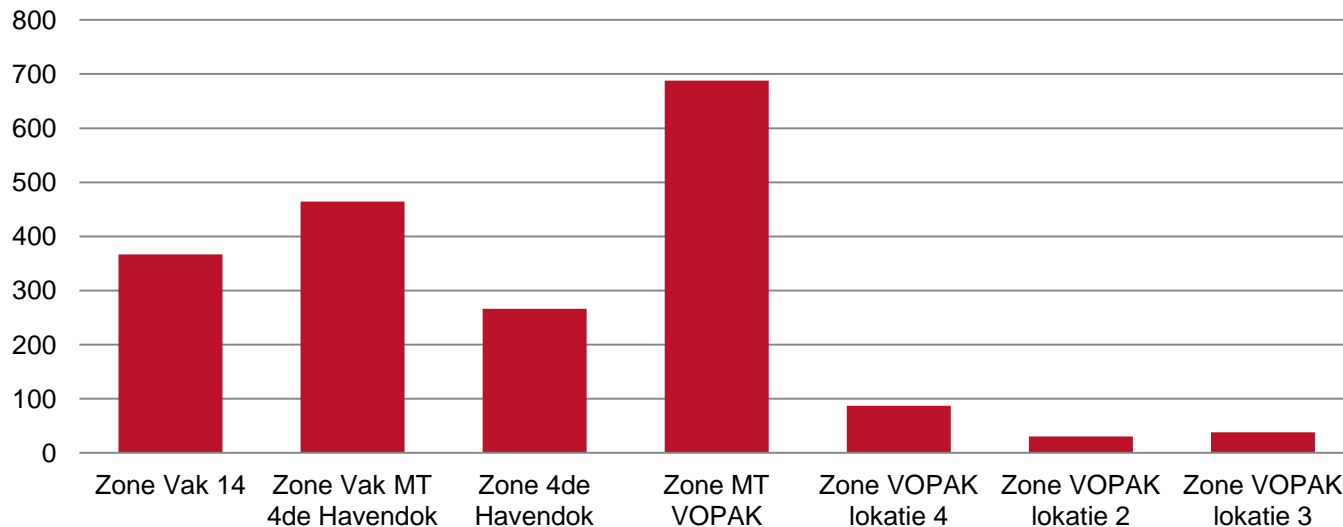
Approximately 1.940 kg TBT and 1.000.000 kg MO will be dredged

Amount of TBT dredged (kg)

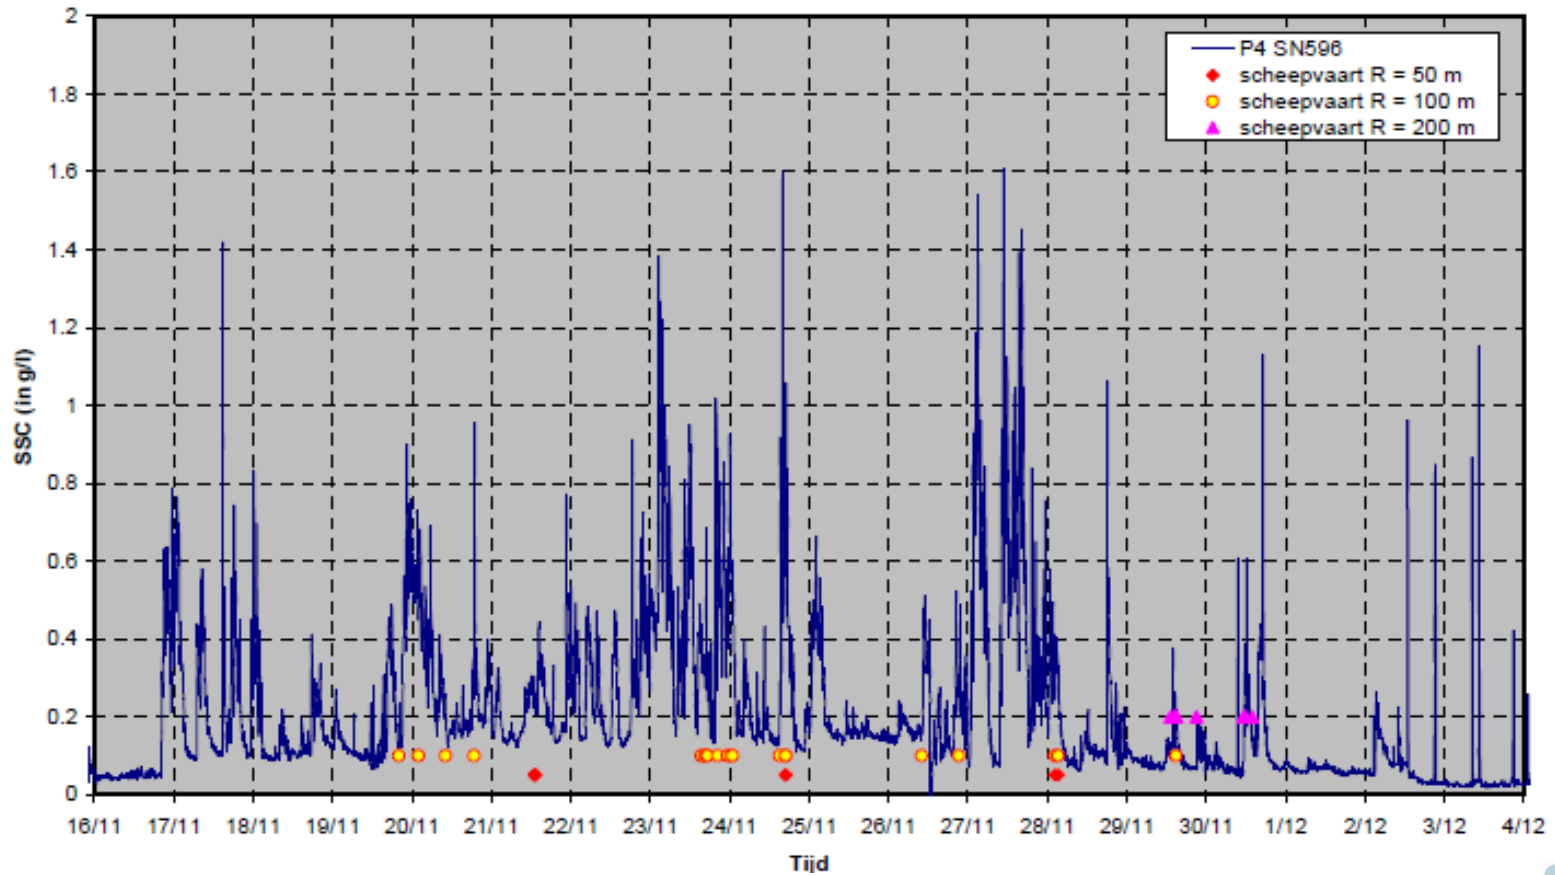
4.2 Results: turbidity is limited in time

Turbiditeitsmonitoring: locatie P4 - Hansadok
16 november 2012 - 3 december 2012.

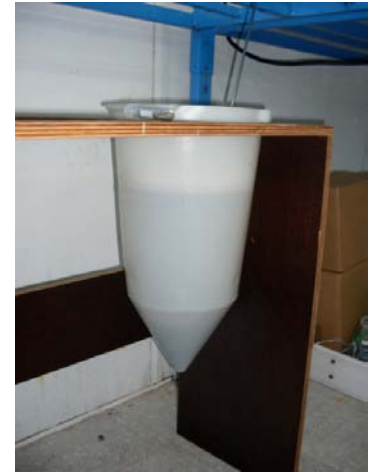
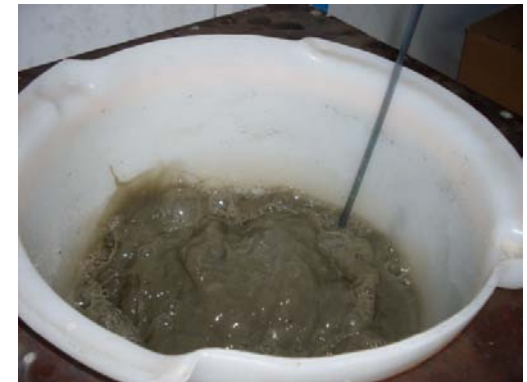
Follow up – resuspension test

- Simulation of dredging events in laboratory conditions
 - Effects of mobilisation of sediments on quality of overlying water in function of time and different mobilisation scenarios
 - To be executed
