The Walsoorden pilot project: a first step in morphological management of the Western Scheldt, conciliating nature preservation and port accessibility

Ir Y. Plancke (FHR)

SEDNET 2009 – October 2009

Flemish Government – Flanders Hydraulics Research

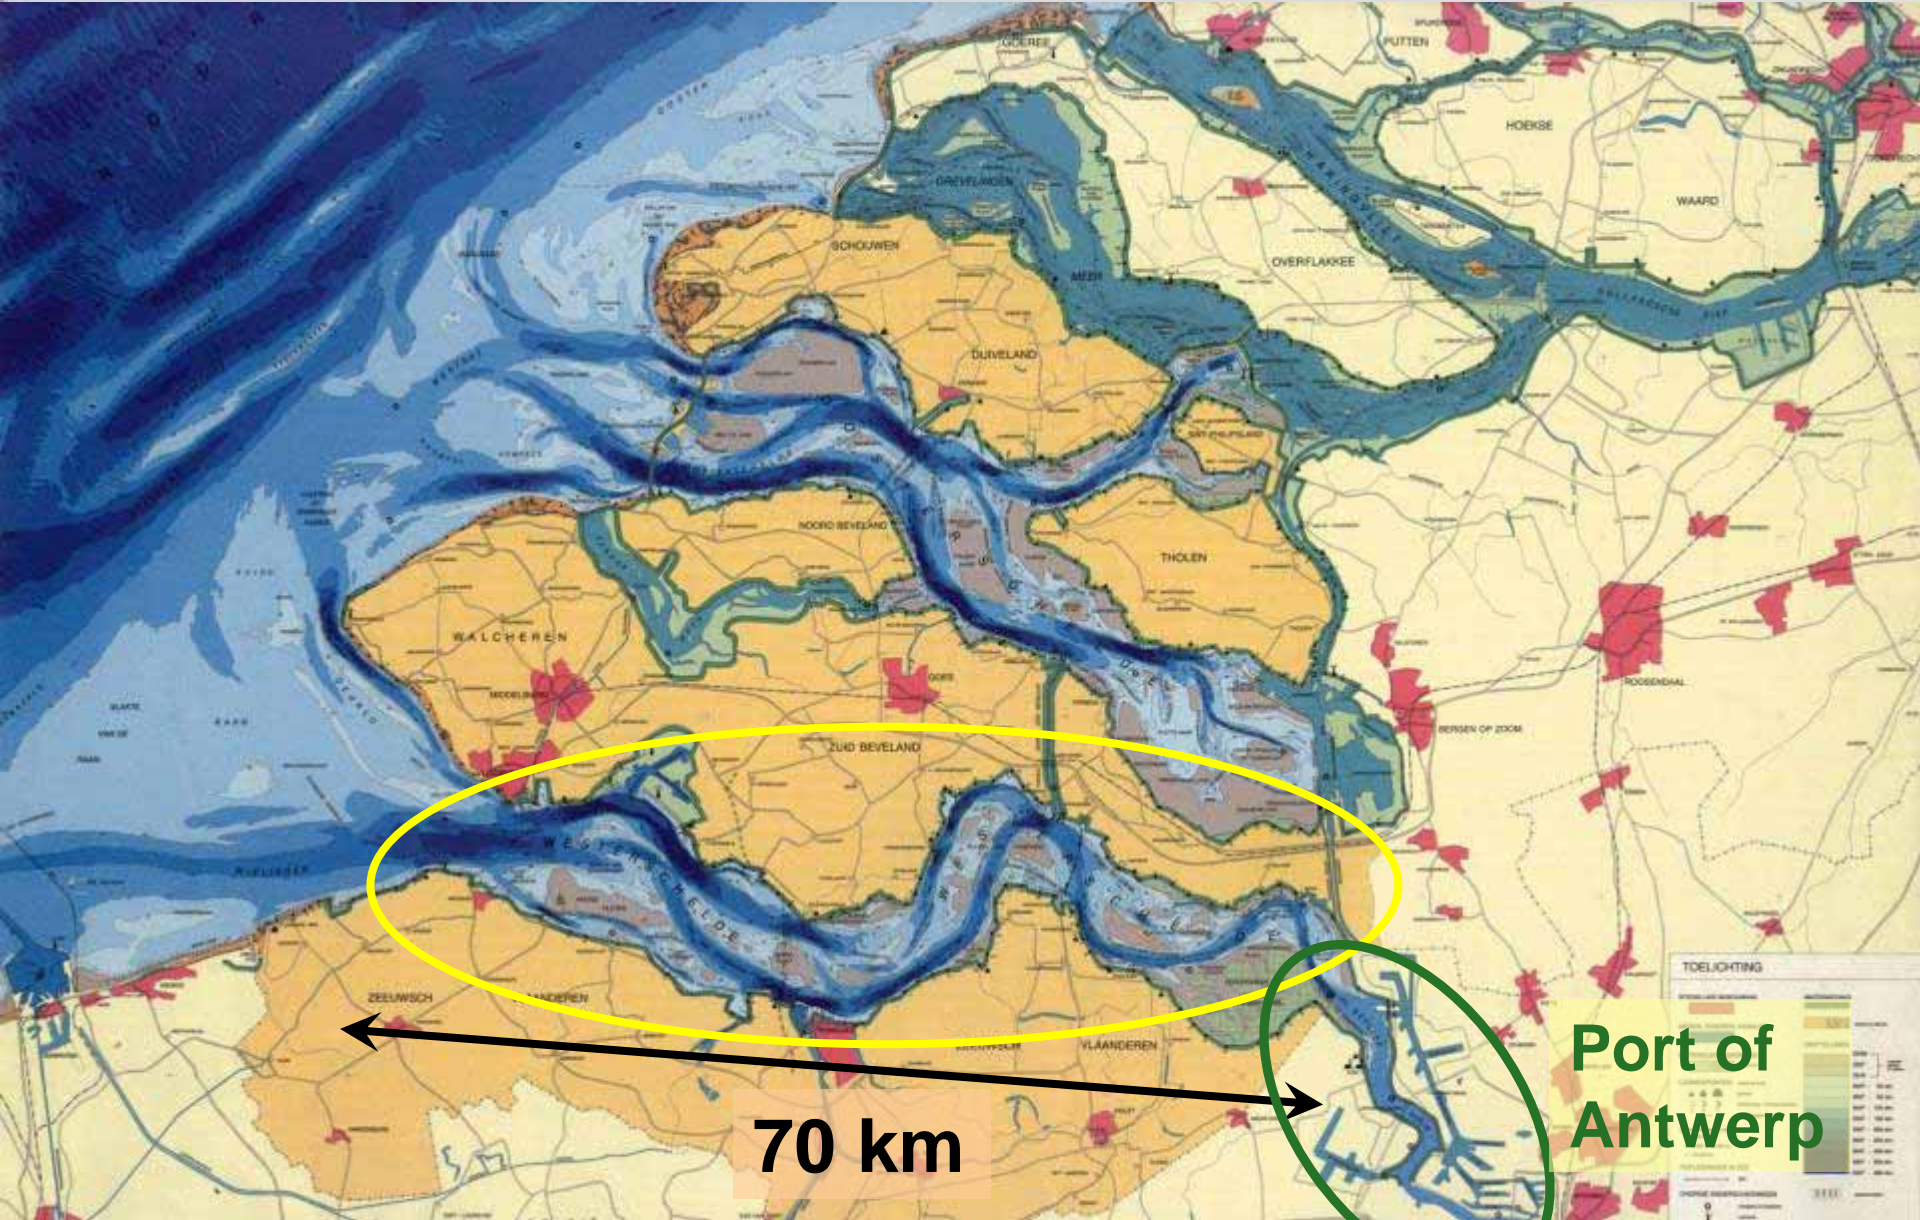
The Western Scheldt

70 km

Port of Antwerp

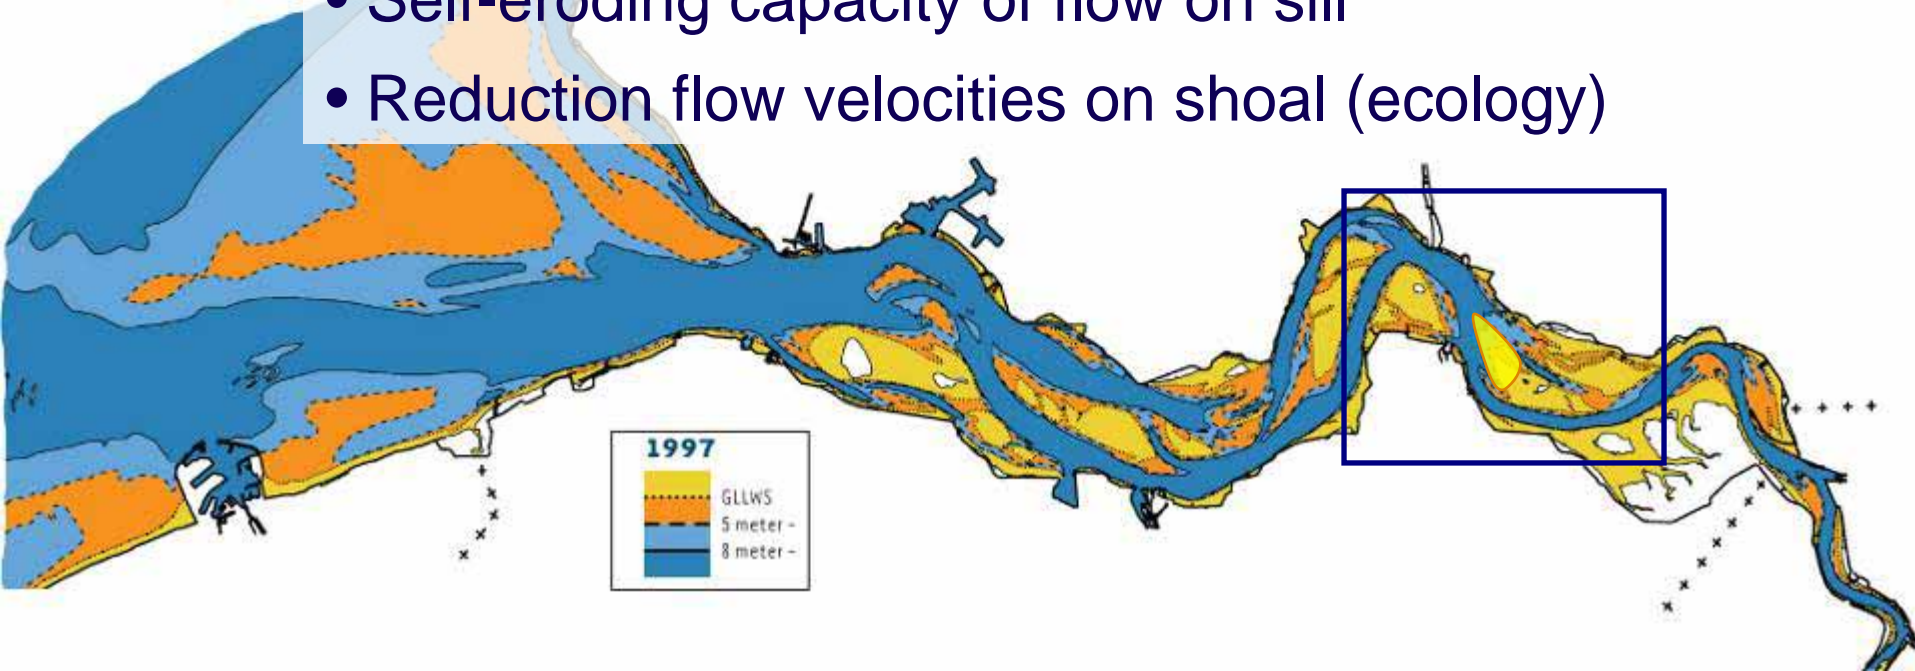
- Distribution of flood current (multiple channel system)
- Self-eroding capacity of flow on sill
- Reduction flow velocities on shoal (ecology)

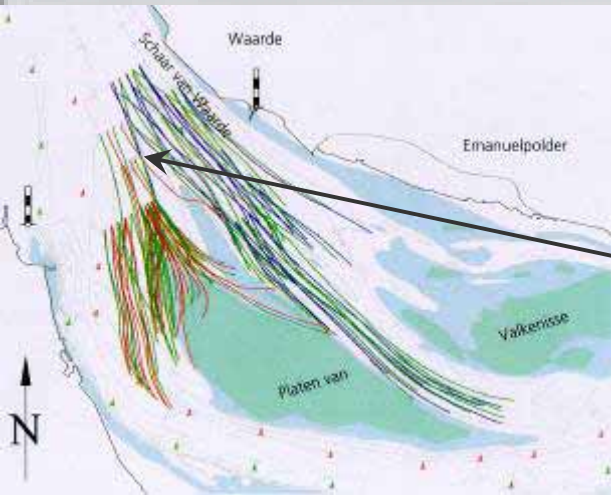
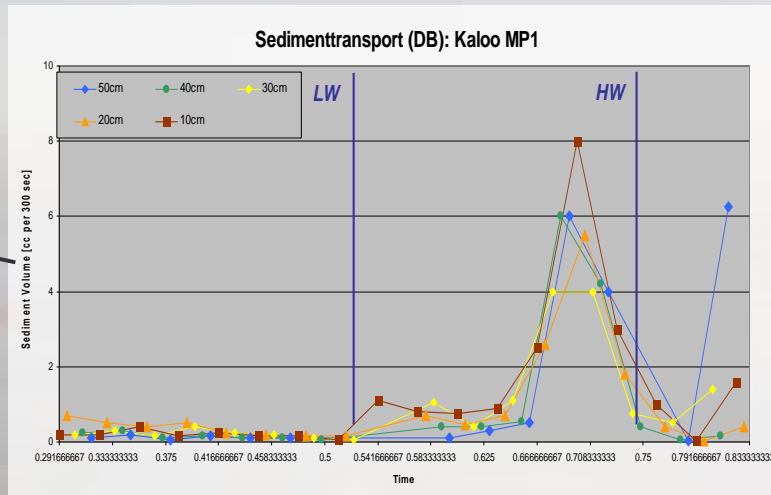
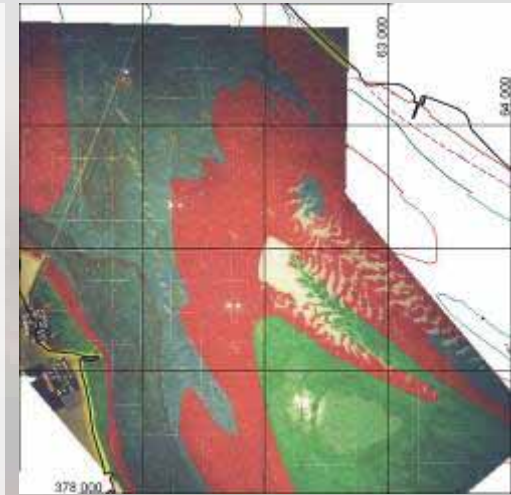
Feasibility study : results

- Field surveys, scale and numerical modelling
- Morphological feasibility
 - NO indications that method is NOT feasible
 - final prove only by in situ disposal test (500.000 m³)
 - Authorities requested “second opinion”

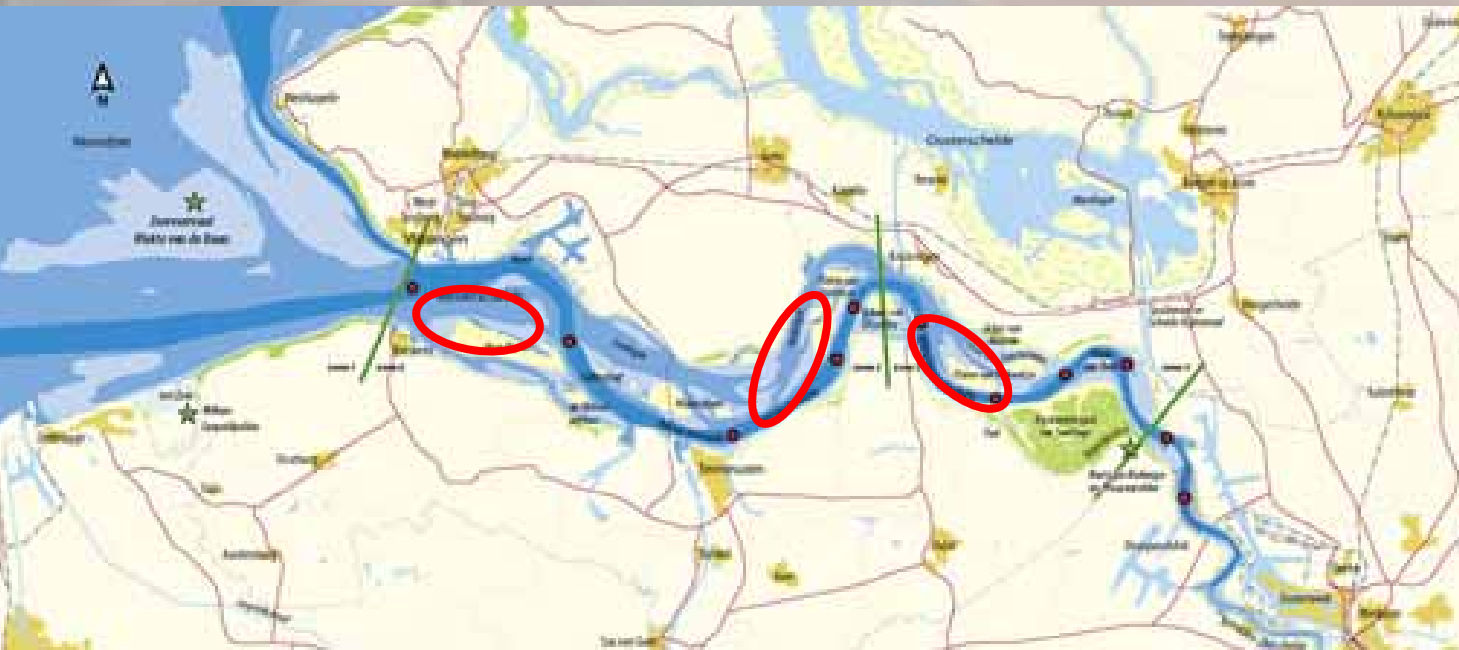
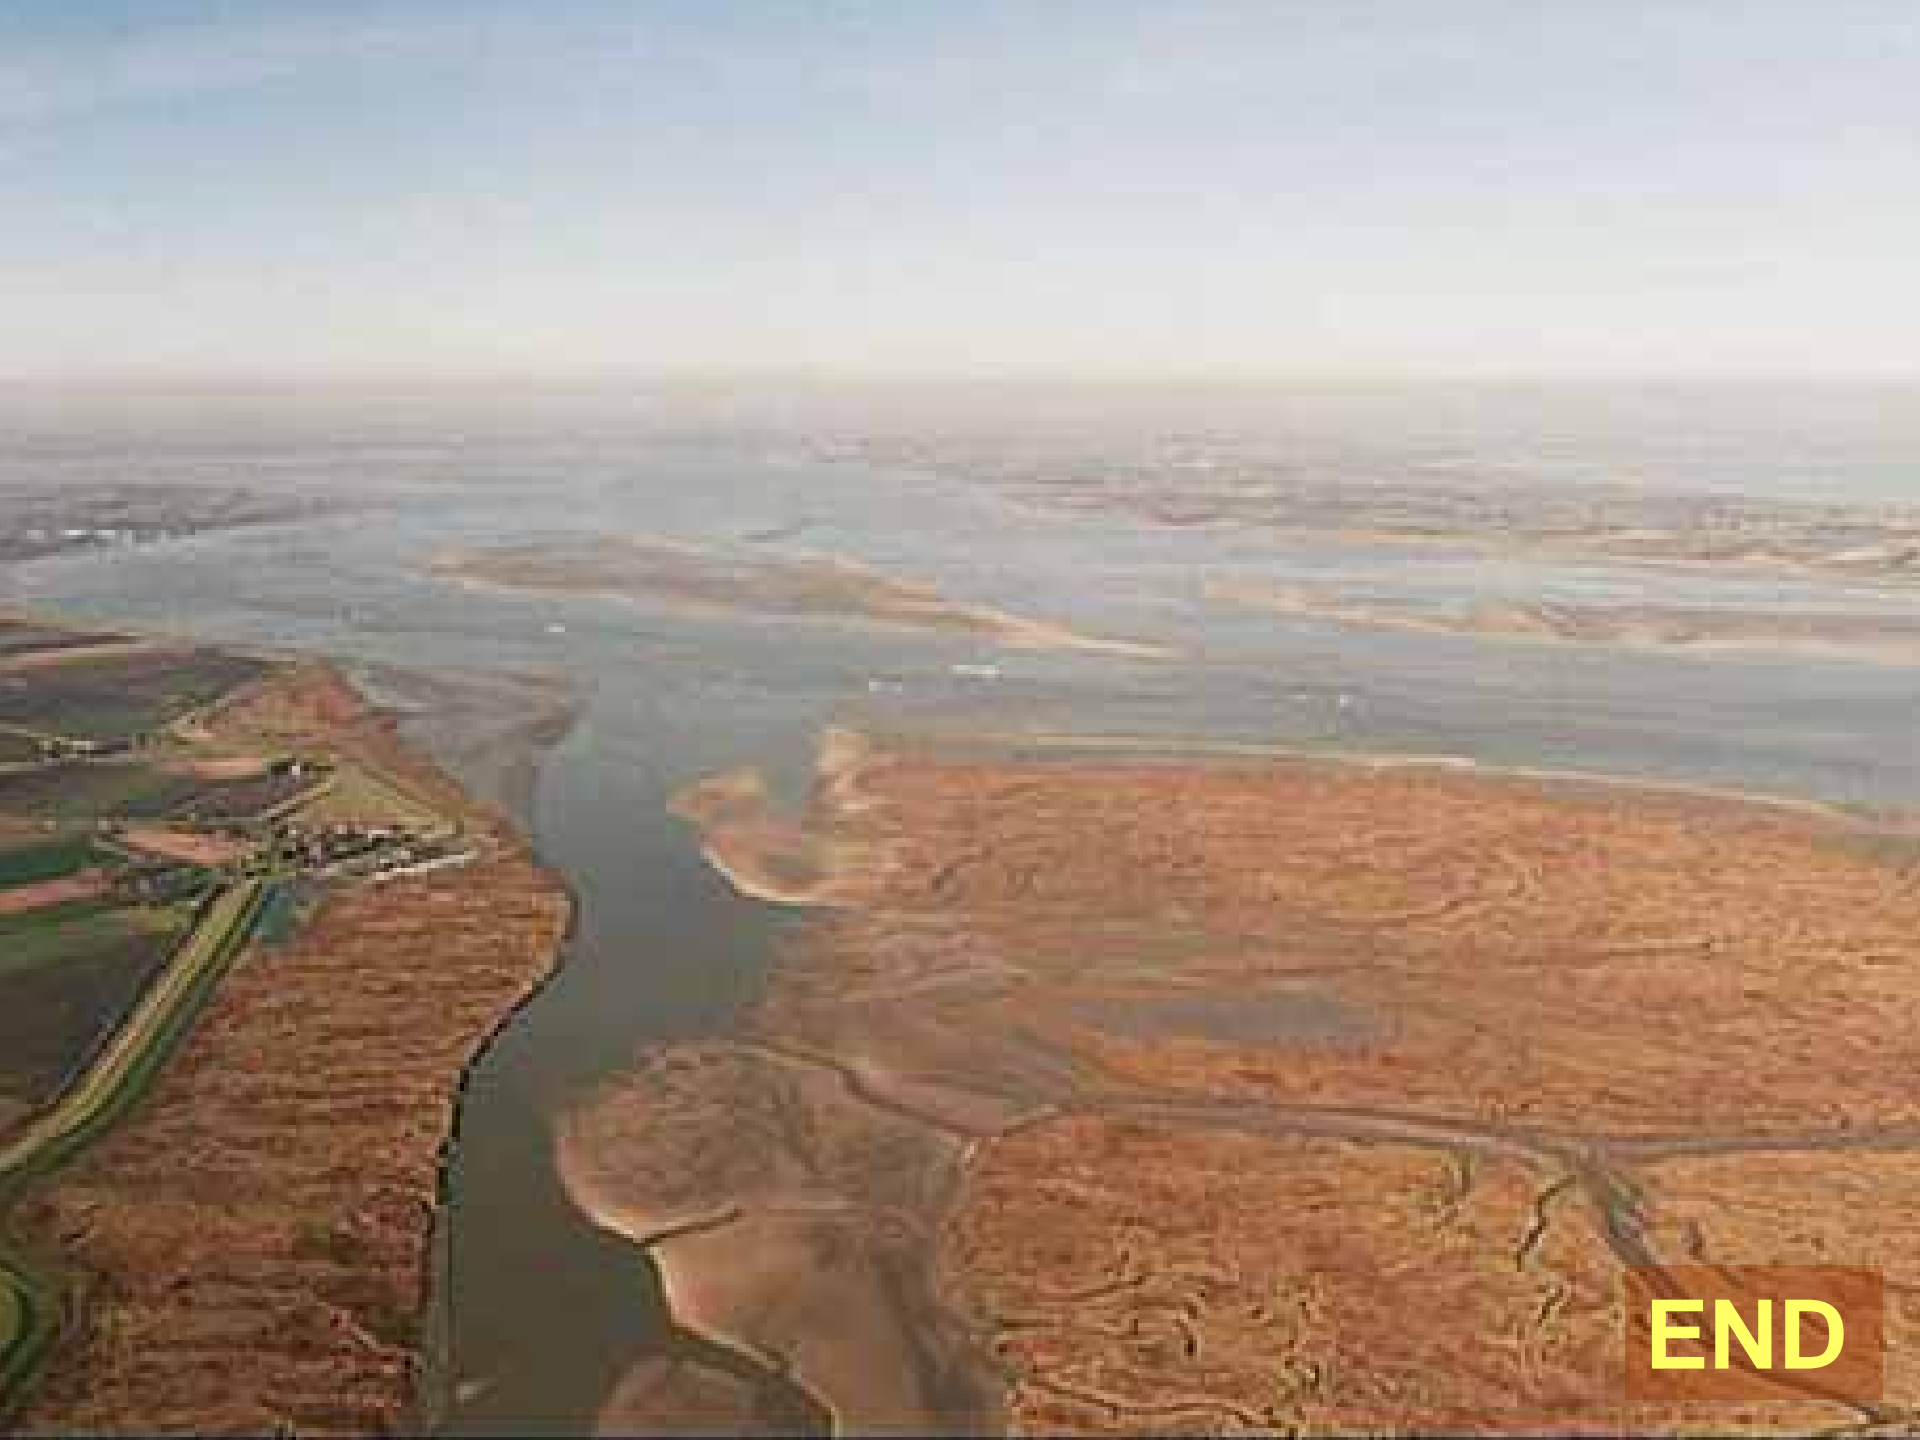
Project deepening navigation channel

- Tide independant accessibility to port of Antwerp for ships with draught up to 131 dm
- Dredging depth of 147dm (12,5% keel clearance)
- Capital dredging works: 7,7 Mm³ in Western Scheldt
- EIA => material used to reshape/extent sandbars

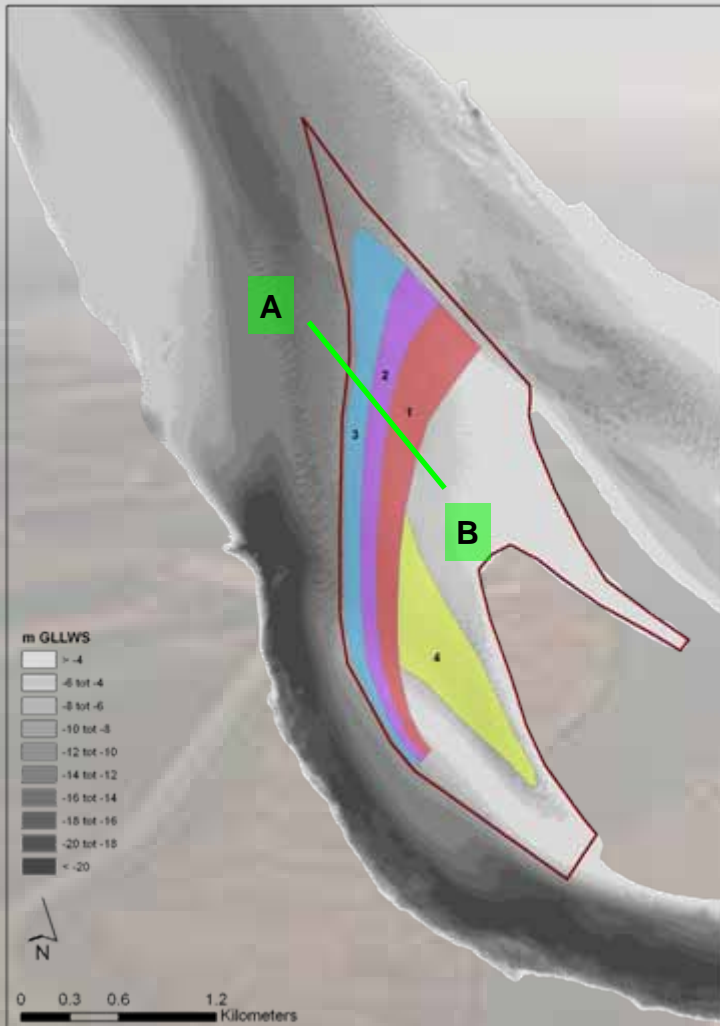
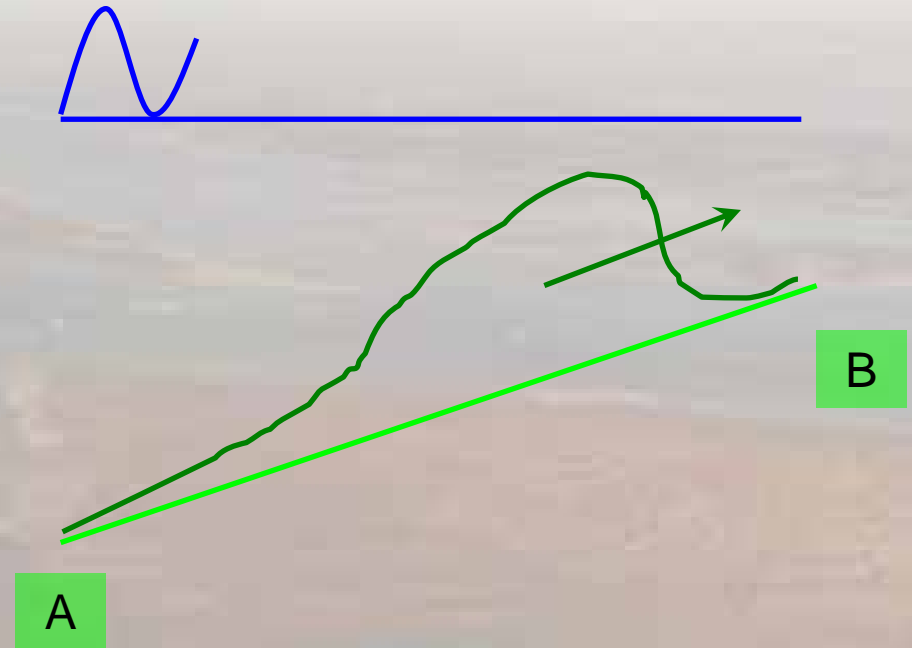
Sandbar of Walsoorden (6,5Mm³)
