Recent incident putting an international river basin under pressure - Historically high PCB-concentrations on the move

Ilka Carls¹, Dr. René Schwartz¹, Michael Bergemann¹, Ute Erhorn¹ & Dr. Henrich Röper²

¹Ministry of Environment and Energy, Hamburg, Germany

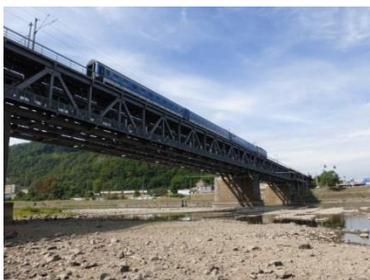
Fig. 1: Railway bridge crossing the Elbe in the city of Ústí nad Labem

According to the Czech Environmental Inspectorate, PCB release was largely caused by maintenance dredging works in the waterway. In contrast, the state water management of the Elbe (Povodí Labe), attributes the cause of the extremely elevated concentrations to a construction site, where the removal of PCB-containing paint of a railway bridge crossing the Elbe in the city of Ústí nad Labem has been conducted improperly (see **Fig. 1**).
