The Elbe gives, the Elbe takes ...

The impact of flood events on backwaters

In the centre of investigation: backwaters of the Elbe

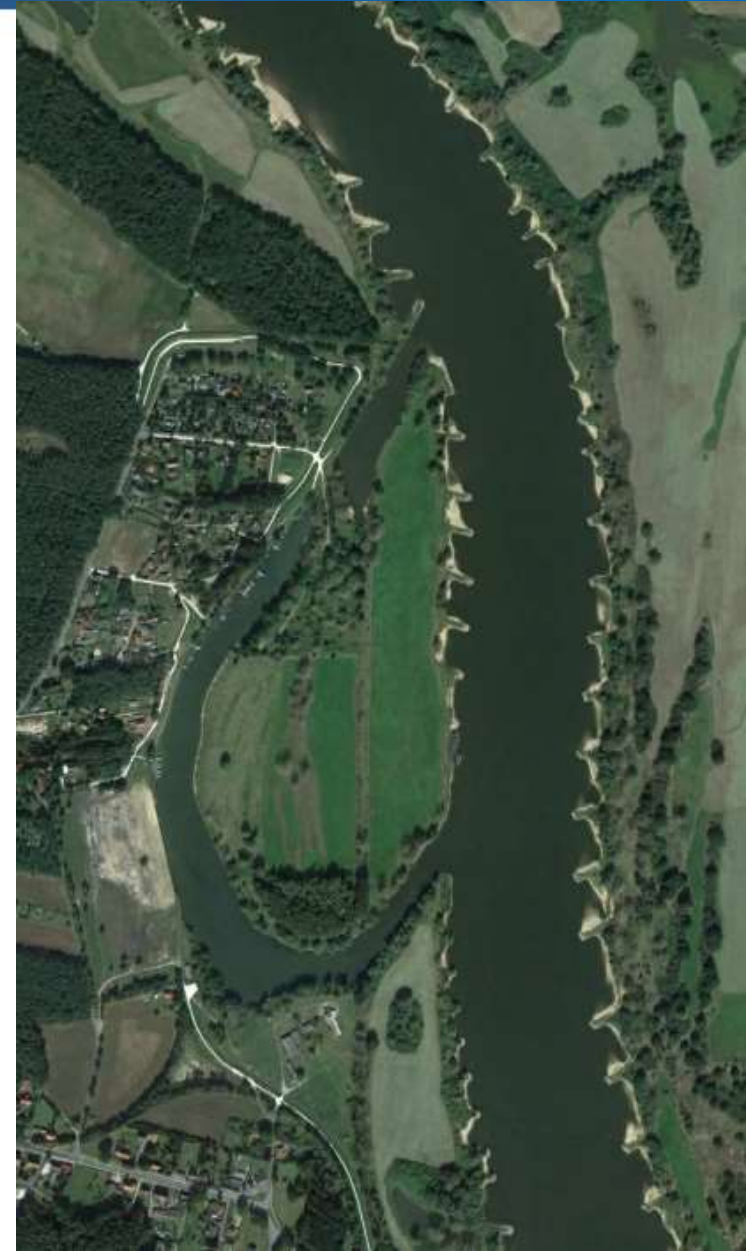
- „Altwässer“: Standing water bodies, not connected to the Elbe at average discharge (MQ)
- „Altarme“: (one-sided) connection at MQ
- Number: ca. 1000 side structures in the floodplain of the German part of the Elbe
- Area: ca 50 km²

15 Backwaters sampled in summer 2014

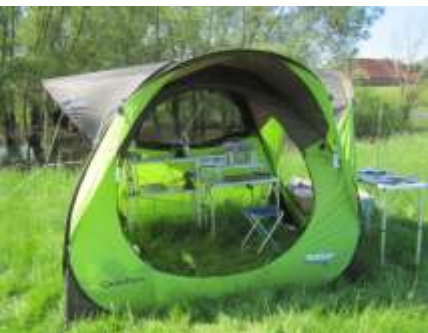
Measurement of erosion stability „on site“

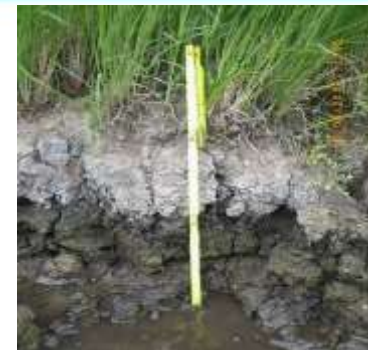
Example: Organics (River-km 376, Ferchland)

Organic substance	Concentration	Upper Threshold Value (ICPE)	Exceedance
Fluoranthene	27 mg/kg	0.18 mg/kg	up to 150
Benzo(a)pyrene	12 mg/kg	0.6 mg/kg	up to 20
PAK (16, acc. to EPA)	152 mg/kg		
pp-DDD	2200 µg/kg	3.2 µg/kg	up to 687
pp-DDT	760 µg/kg	3 µg/kg	up to 253
Hexachlorobenzene	1200 µg/kg	17 µg/kg	up to 70

All these substances are accumulative in organisms

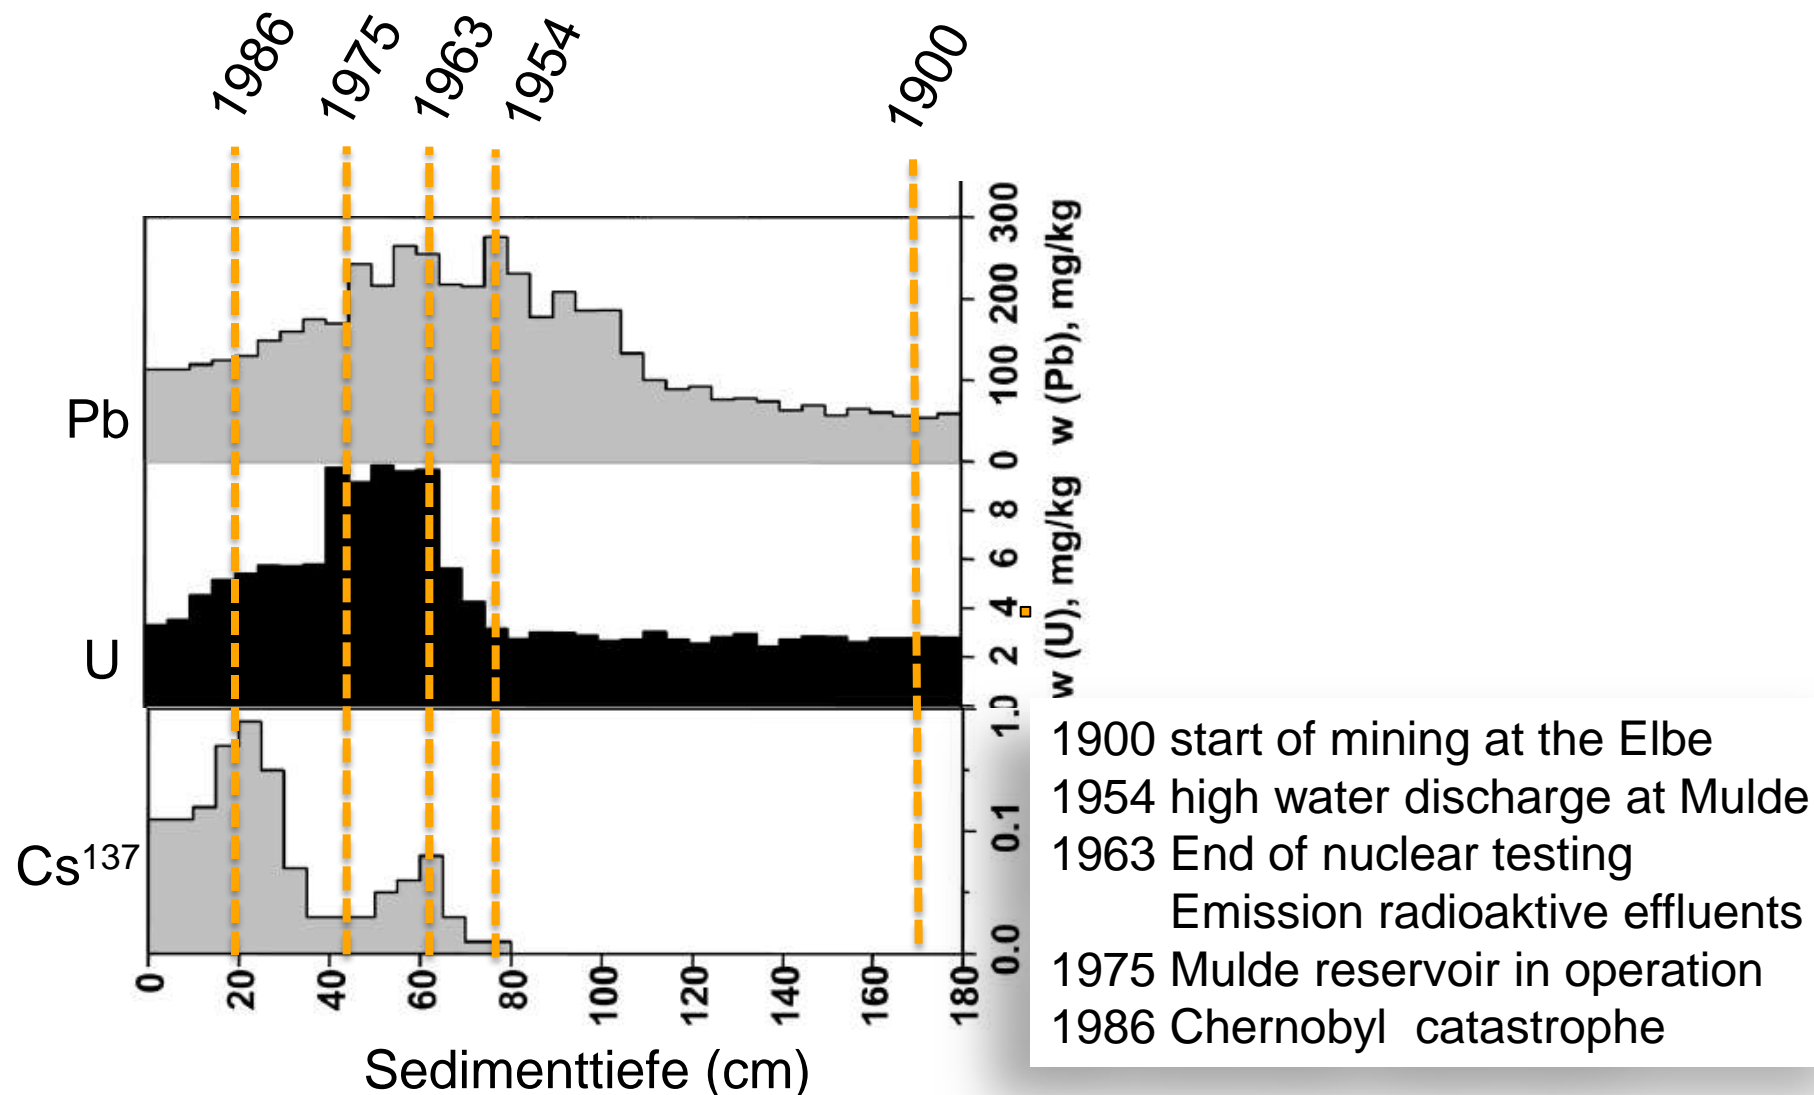
Sediment cores, river-km 438, from 1998 (Krüger et al. 2006):

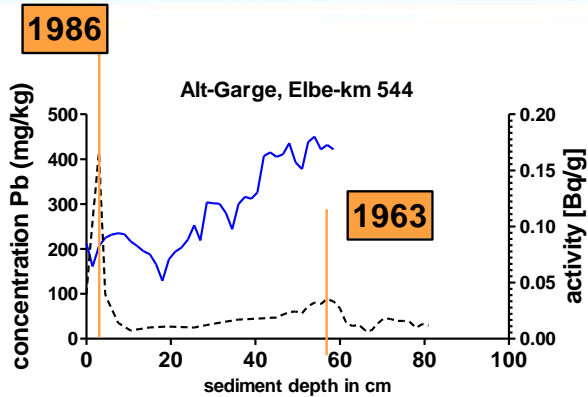
Two ^{137}Cs peaks (1986, 1963)

Pb-peak in ca. 50 cm depth
1975: Upstream reservoir, „Muldestausee“,
was set into operation, reducing Pb
concentrations in suspended matter

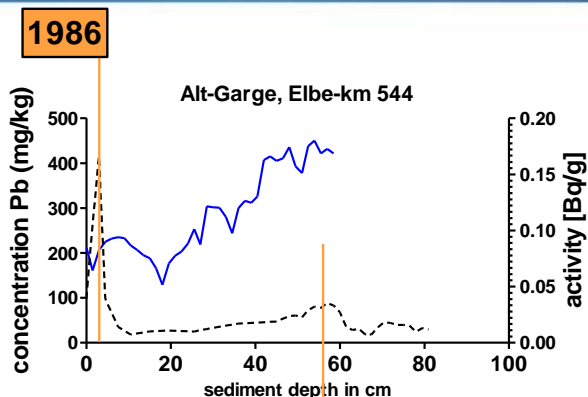
Two ^{137}Cs peaks (1986, 1963)

Pb-peak in ca. 50 cm depth
1975: Upstream reservoir, „Muldestausee“,
was set into operation, reducing Pb
concentrations in suspended matter

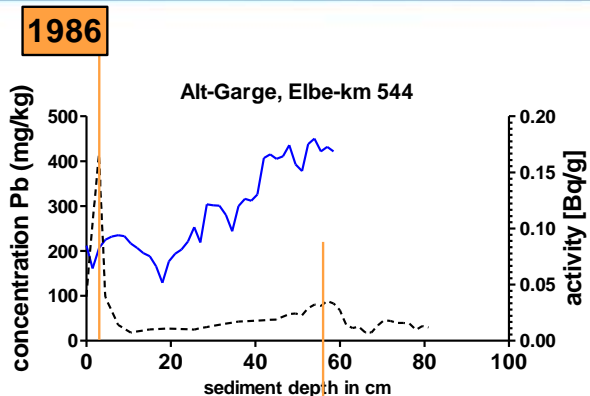
Backwater sediment
protected by dam from flooding
Sedimentation rate (calculated):
2.3 cm/year

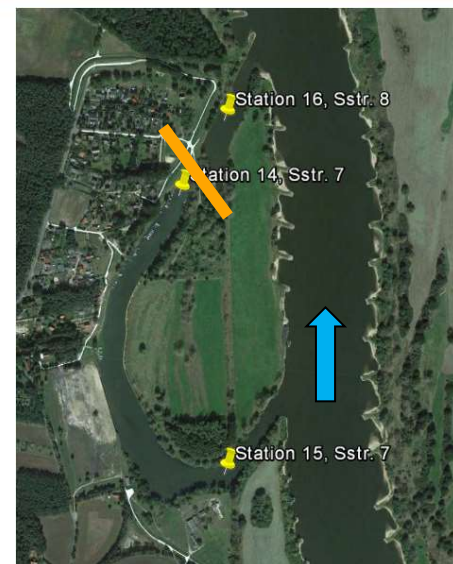
Pb peaks close to the surface

No ¹³⁷Cs signal from 1986

¹³⁷Cs peak from 1963 would have

been expected in 1 m depth

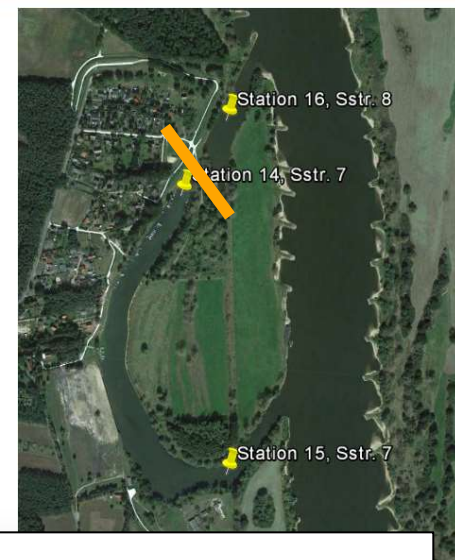
Backwater sediment
protected by dam from flooding
Sedimentation rate (calculated):
2.3 cm/year

Earlier investigations had detected the
Chernobyl-Peak

- Prior to 1993 (Prange et al. 1997)
- 1997/98 (Zachmann et al. 2013)
- 1998 (Krüger et al. 2006)

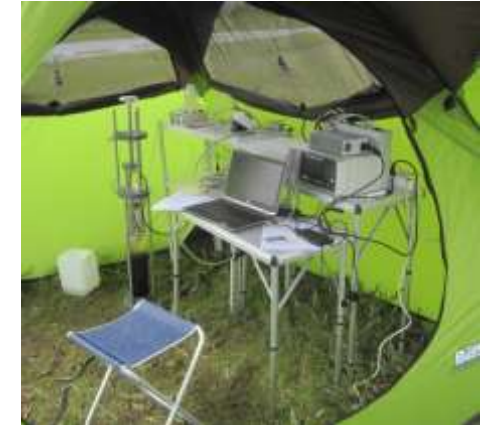
Prinzip:
Schrittweise Erhöhung der Scherkräfte
Monitoring der Trübung

From Thomsen & Gust, 2000, modified

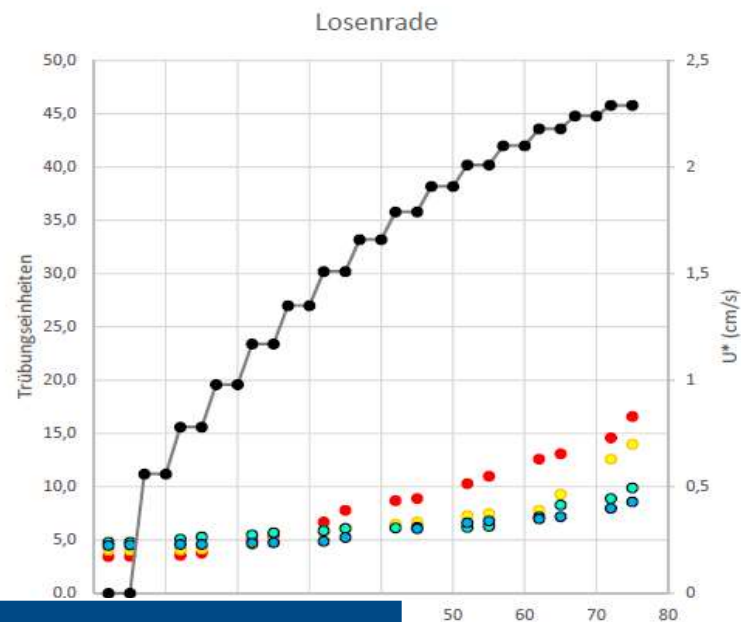
Klassifikation der Erosionsmessungen

Hohe u_{crit} (>2 cm/s),
geringe erodierte Masse

Mittlere u_{crit} (1 bis 2 cm/s),
Moderate erodierte Masse

geringe u_{crit} (<1 cm/s),
Hohe erodierte Masse

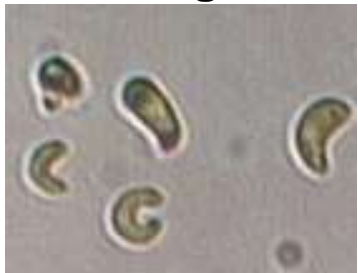
Green algae

Elutriate

Raphidocelis subcapitata

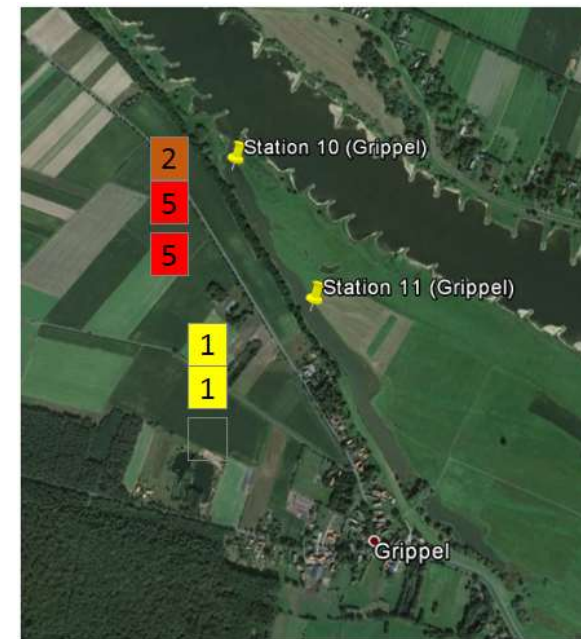
Ergebnisse 2: Hinweis auf Sedimentumlagerung

- Station 600 m entfernt von der Mündung
- zwischengelagerte Sandschicht
 - Erhöhung des Feinsandanteils von 2013 → 2014
 - breiter Cs-Peak von 1963
 - schmaler Pb-Peak bei 50 cm

→ Abtrag von Material, Umlagerungen zwischen 2013-2014

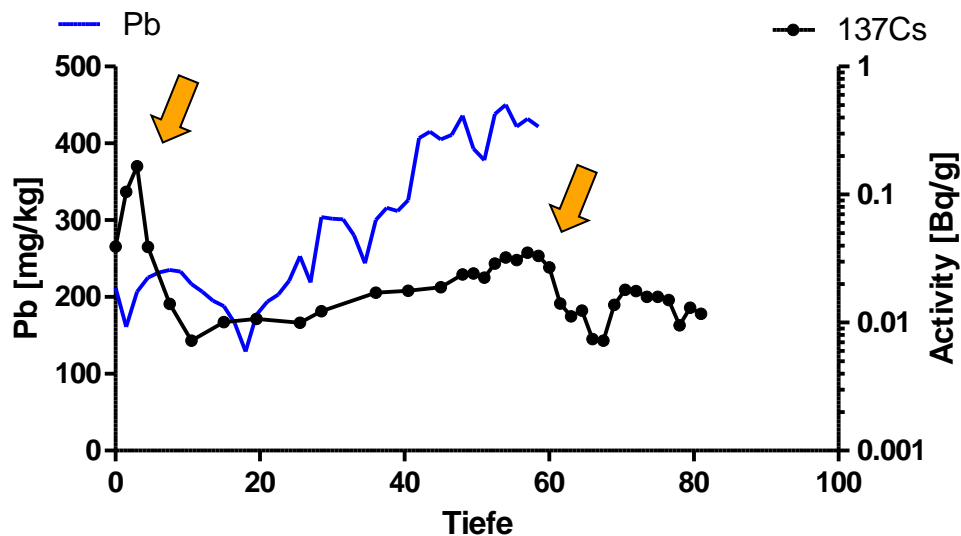
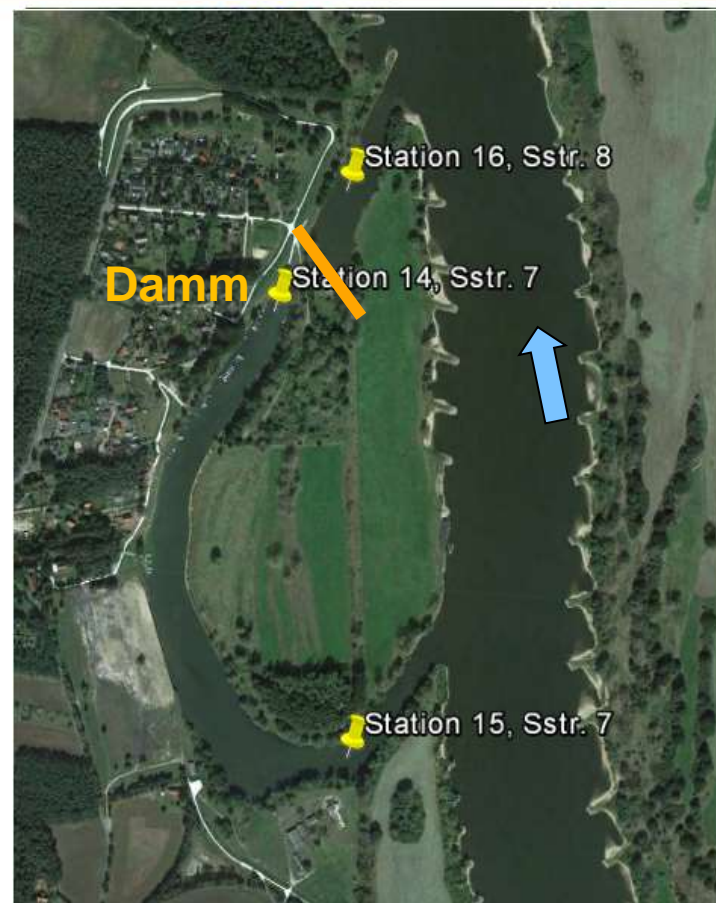
Kern 16: Alt-Garge (uSt)

Two ^{137}Cs peaks (1986, 1963)

Pb-Peak in ca. 50 cm depth

Backwater protected by dam from flooding

Sedimentation rate (calculated): 2,3 cm/year

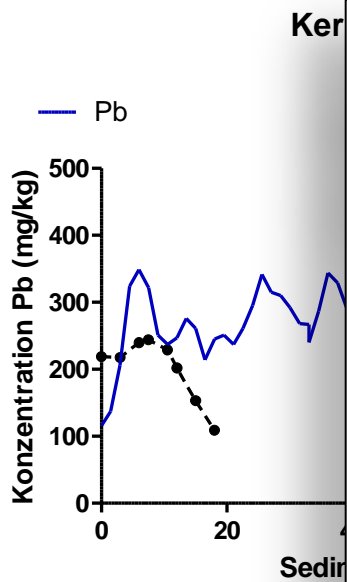
Earlier investigations had detected the Chernobyl-Peak

- Prior to 1993 (Prange et al. 1997)
- 1997/98 (Zachmann et al. 2013)
- 1998 (Krüger et al. 2006)

→ Erosion of ca. 1 m sediment since 1998?

- **Pb peaks** close to the surface.
- No ^{137}Cs signal from 1986
- ^{137}Cs peak from 1963 would have been expected in 1 m depth
- Similar pattern in 6 from 8 backwaters
