Impacts on the marine environment by long term use of a deposit site in the German Bight

Uwe Hentschke¹, Rolf Lüschow², Maja Karrasch², Birgit Schubert¹

¹Federal Institute of Hydrology, Am Mainzer Tor 1, 56072 Koblenz, Germany

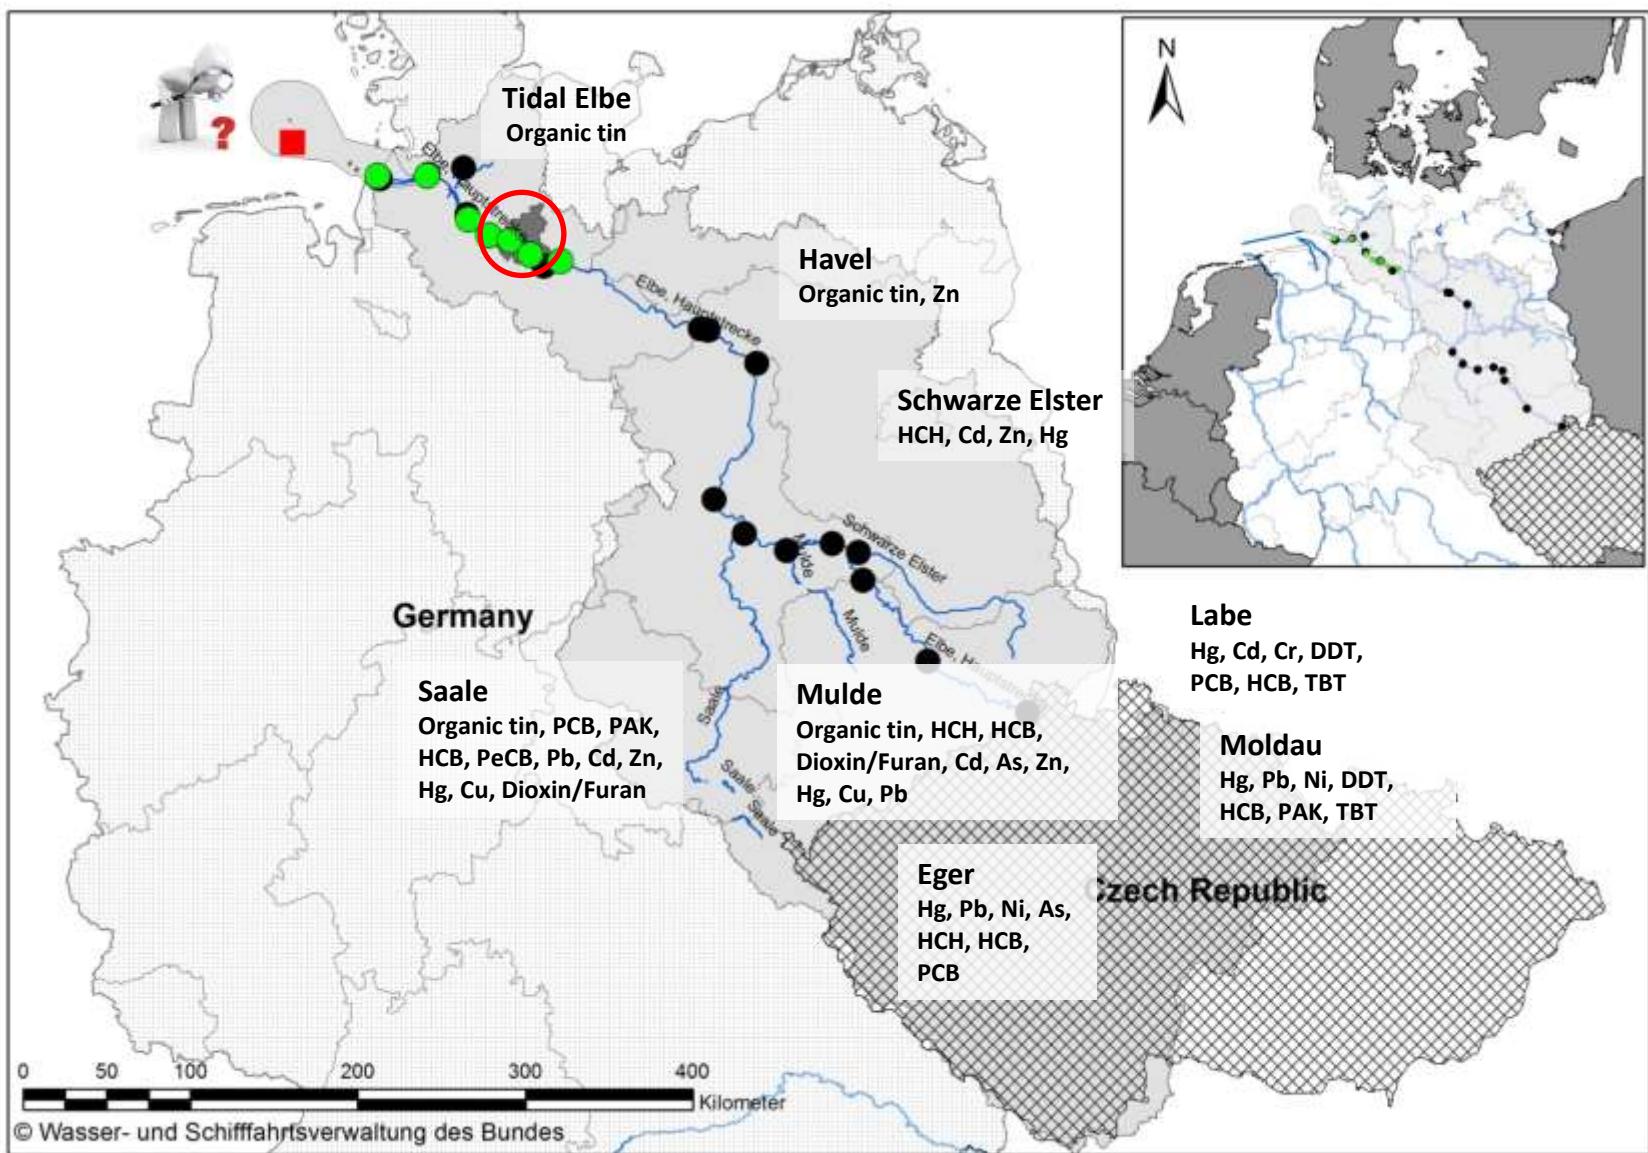
- Contamination of dredged material?

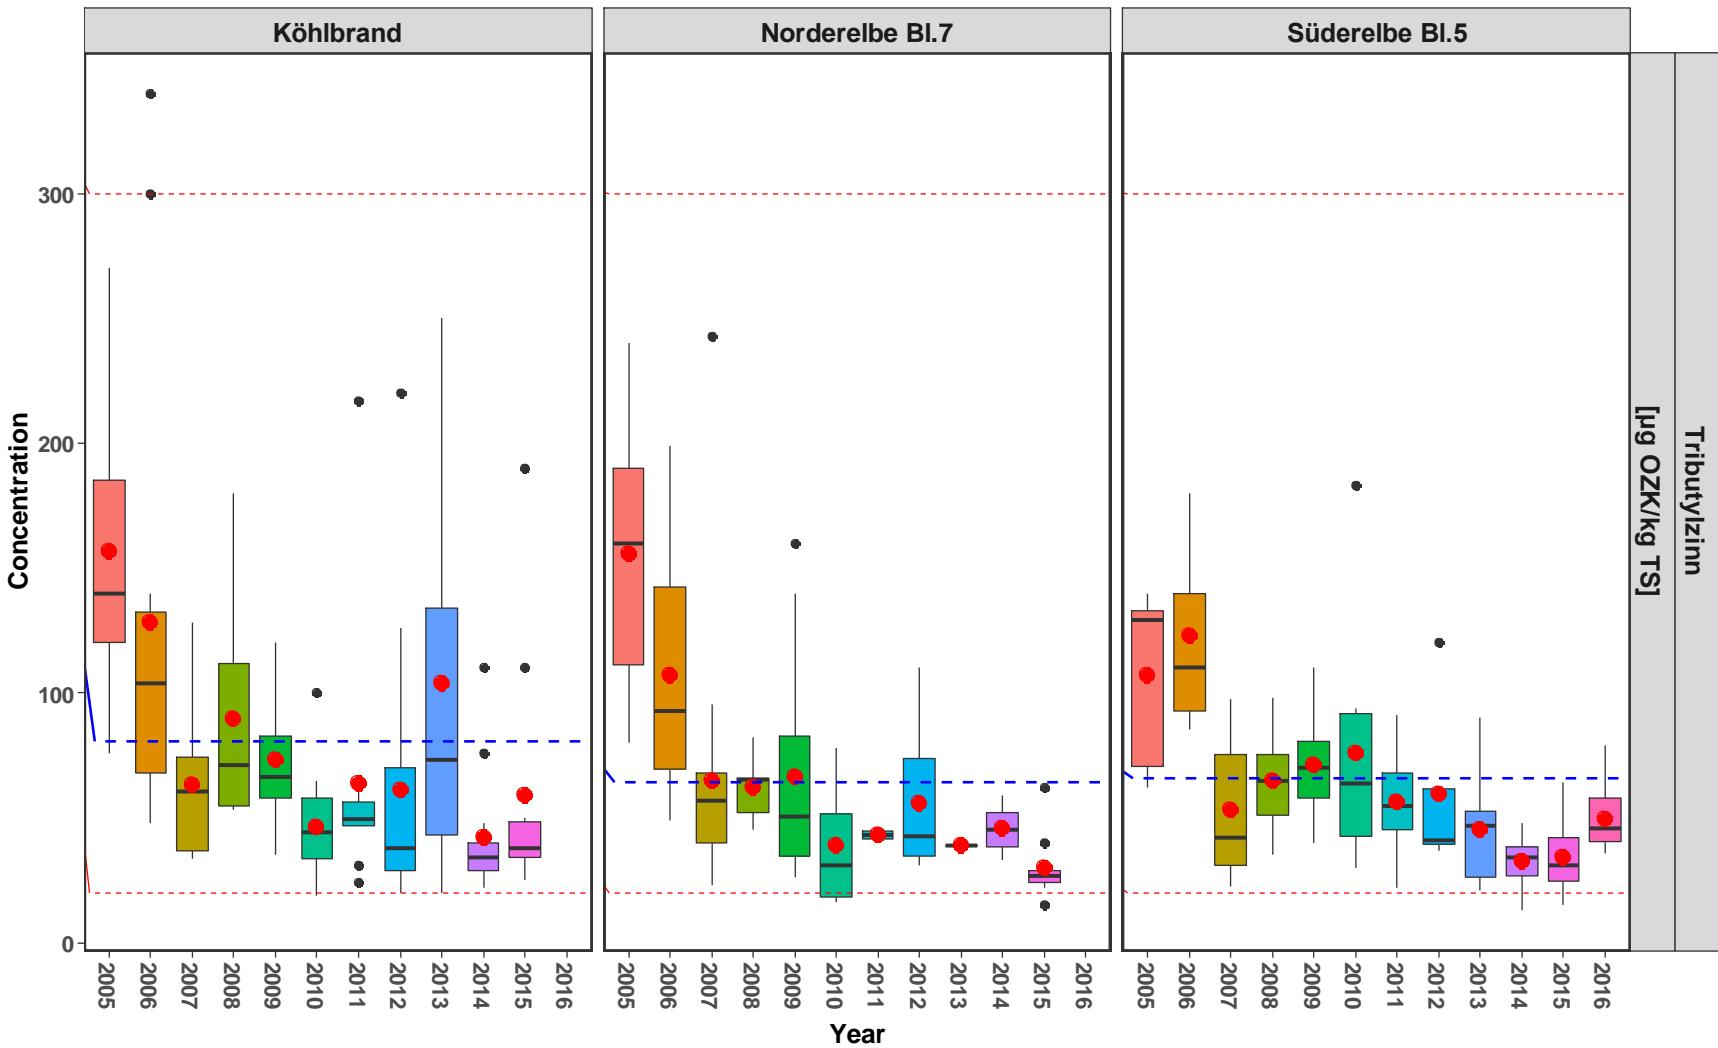
- Influence on natural reserves?

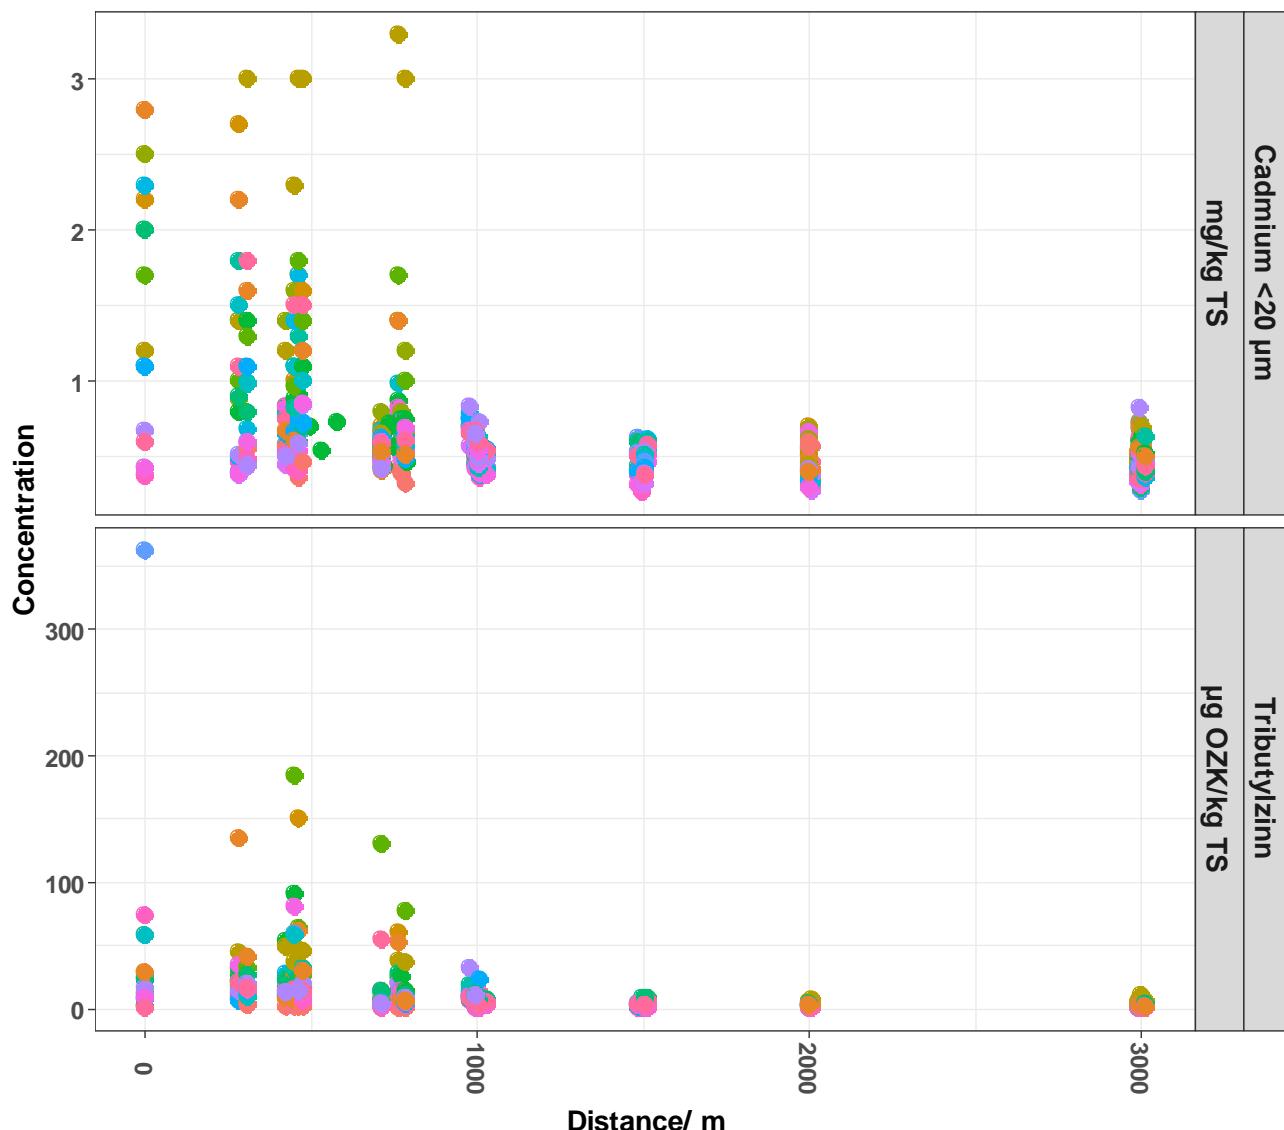
- The dredged material has to be disposed so that it remains largely in the intended application zone

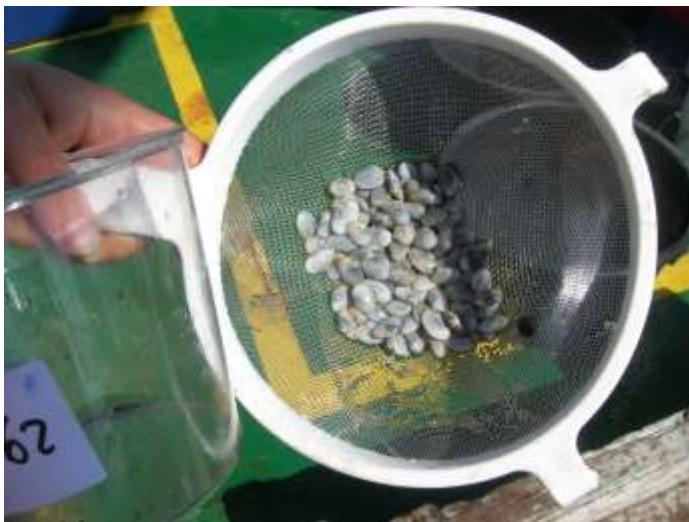
No. of replicates *Abra alba*

2014	1 km	1,5-km	AU2	6-km	R1
July	5	4	5	5	3
September	5	5	5	5	4

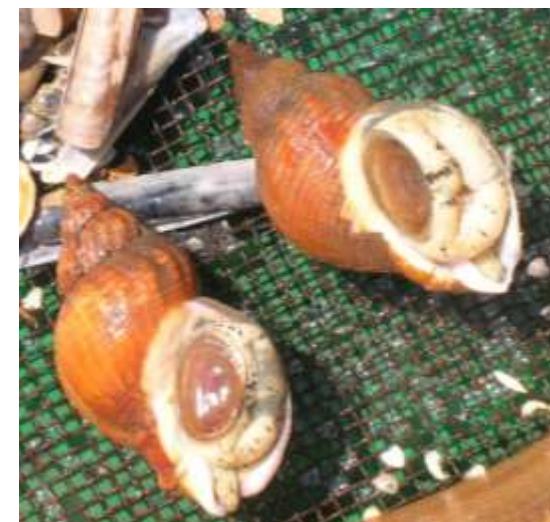
No. of replicates *Buccinum undatum*

2014	Center	1 km	2 km	3 km	R1	R2	R3	Sum
July	10	40	40	20	10	10	10	140
September	10	40	40	20	10	10	10	140

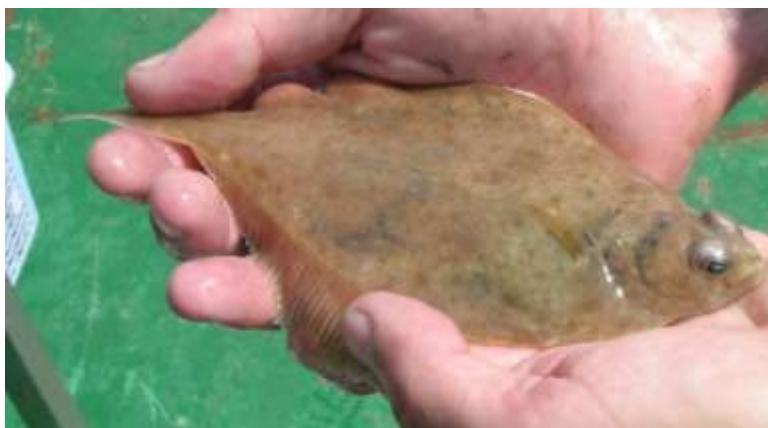
No. of replicates *Limanda limanda*
liver/muscle

2014	1 km	3 km	R1	R3	Sum
July	15/5	15/5	15/5	15/5	60/20
September	15/5	15/5	15/5	15/5	60/20

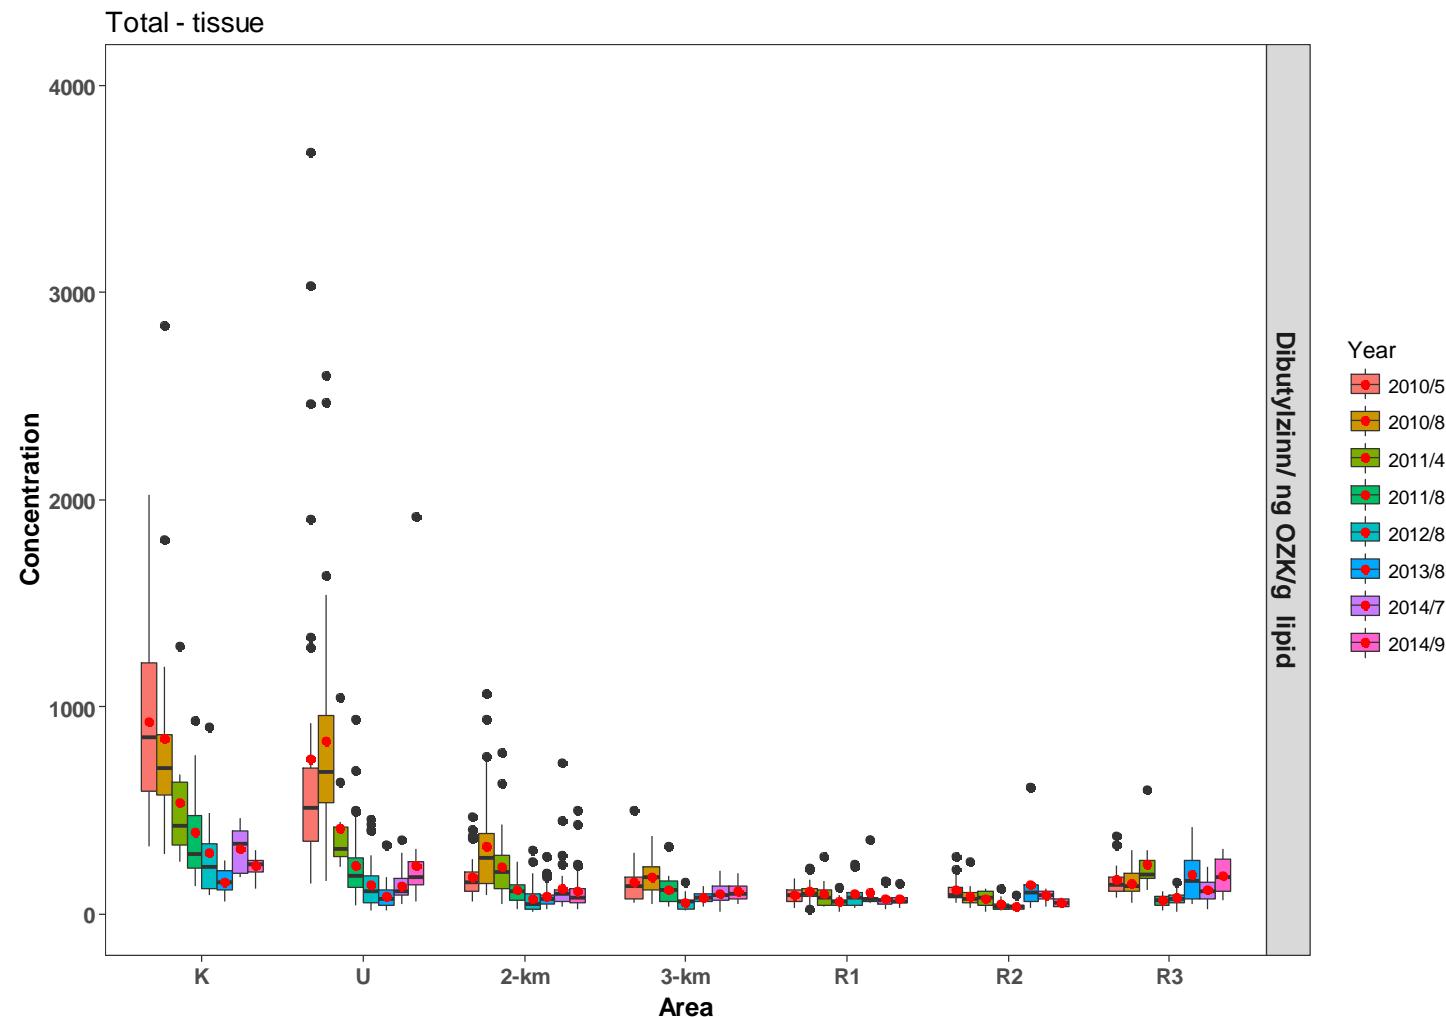
- Significant bioaccumulation outside of the disposal site?

2014/7	Kruskal-Wallis rank sum test	Nemenyi-test
	p < 0,001	K > 2-km 3-km R1, R2
2014/9	Kruskal-Wallis rank sum test	Nemenyi-test
	p < 0,001	K, U > 3-km R1, R2

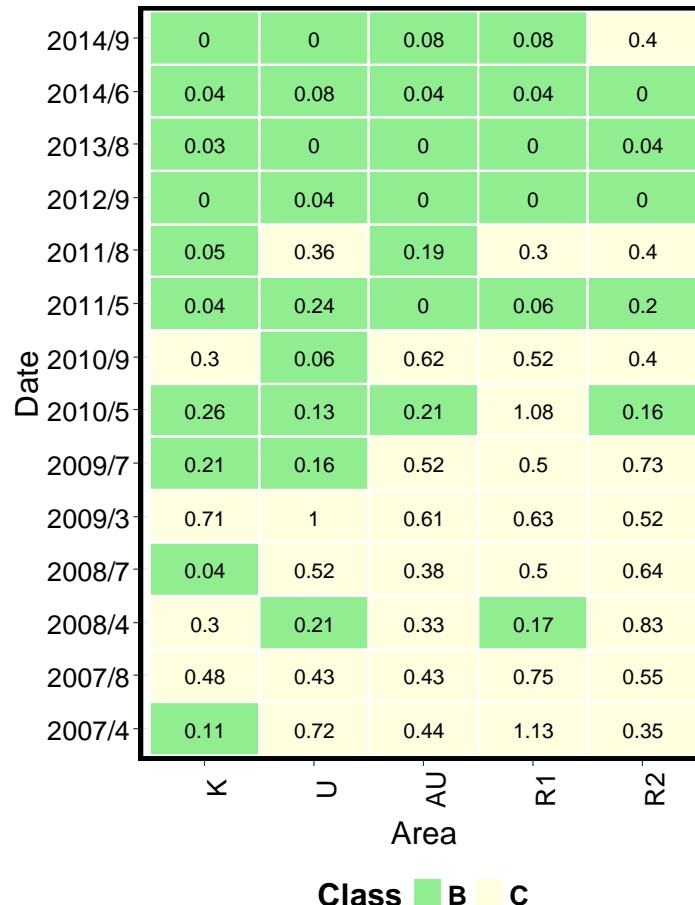
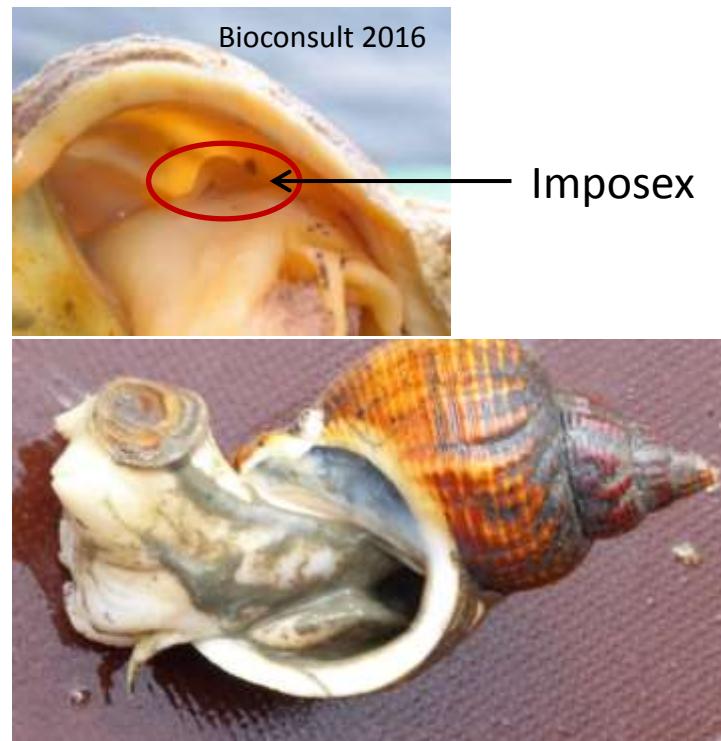
- Significant bioaccumulation outside of the disposal site?
- PCI Penis Classification Index-

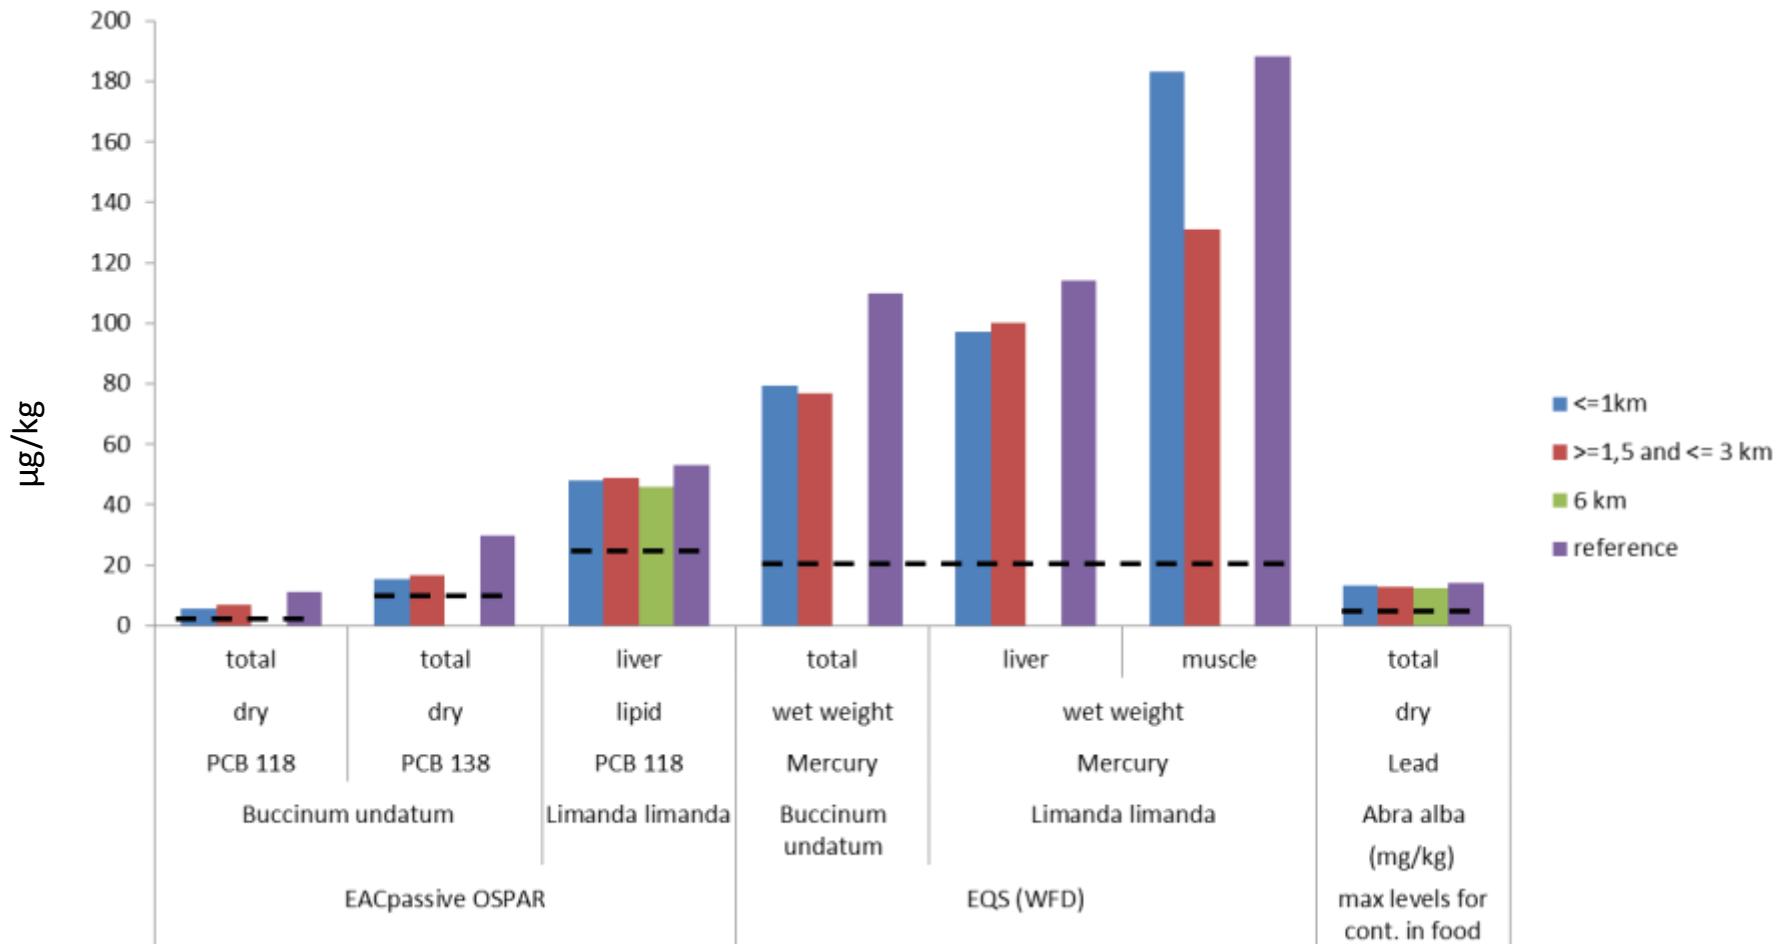
•Assessment according to EAC and environmental quality standards
