# PCB ON THE MOVE

Recent incident putting the international Elbe river basin under pressure

Ilka Carls, U. Ehrhorn, M. Bergemann, Dr. H. Röper & Dr. R. Schwartz

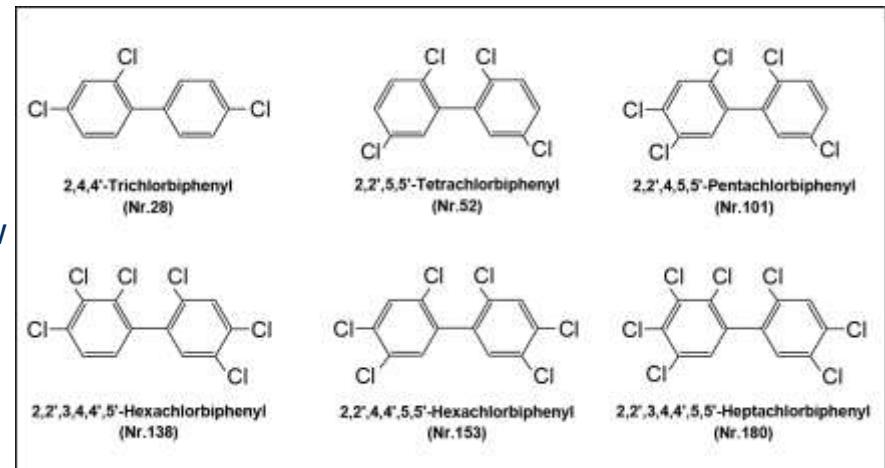
chemical structure of the six characteristic PCB-congeners  
by Ballschmiter & Zell

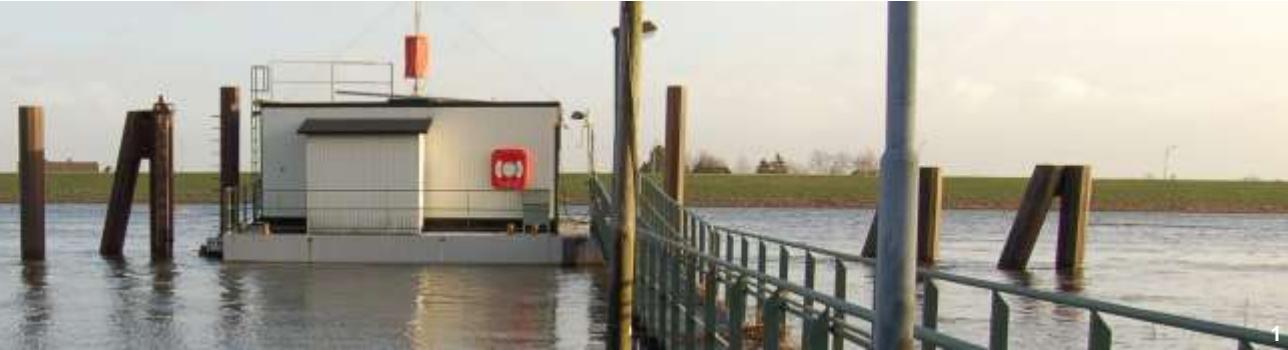
Monitoring station „Bunthaus“, Hamburg

- ▶ **settling tanks**  
(monthly composite samples,  
suspended fresh sediments)
- ▶ **centrifuge**  
(individual samples,  
suspended matter)
- ▶ **grabber / scraper**  
(individual samples,  
sediment)

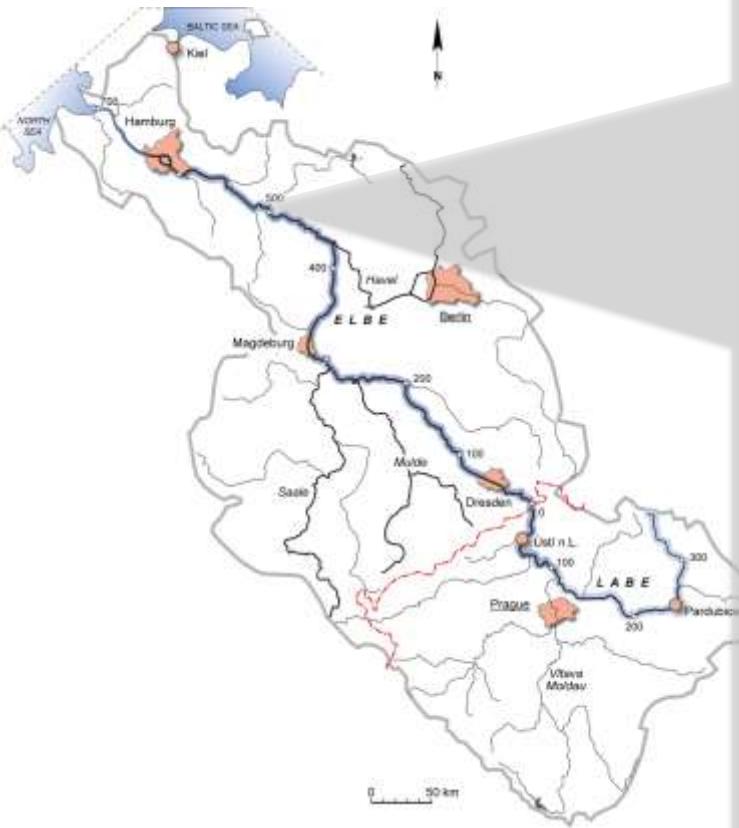
## PCB-contents & -loads (1987 – 2014)

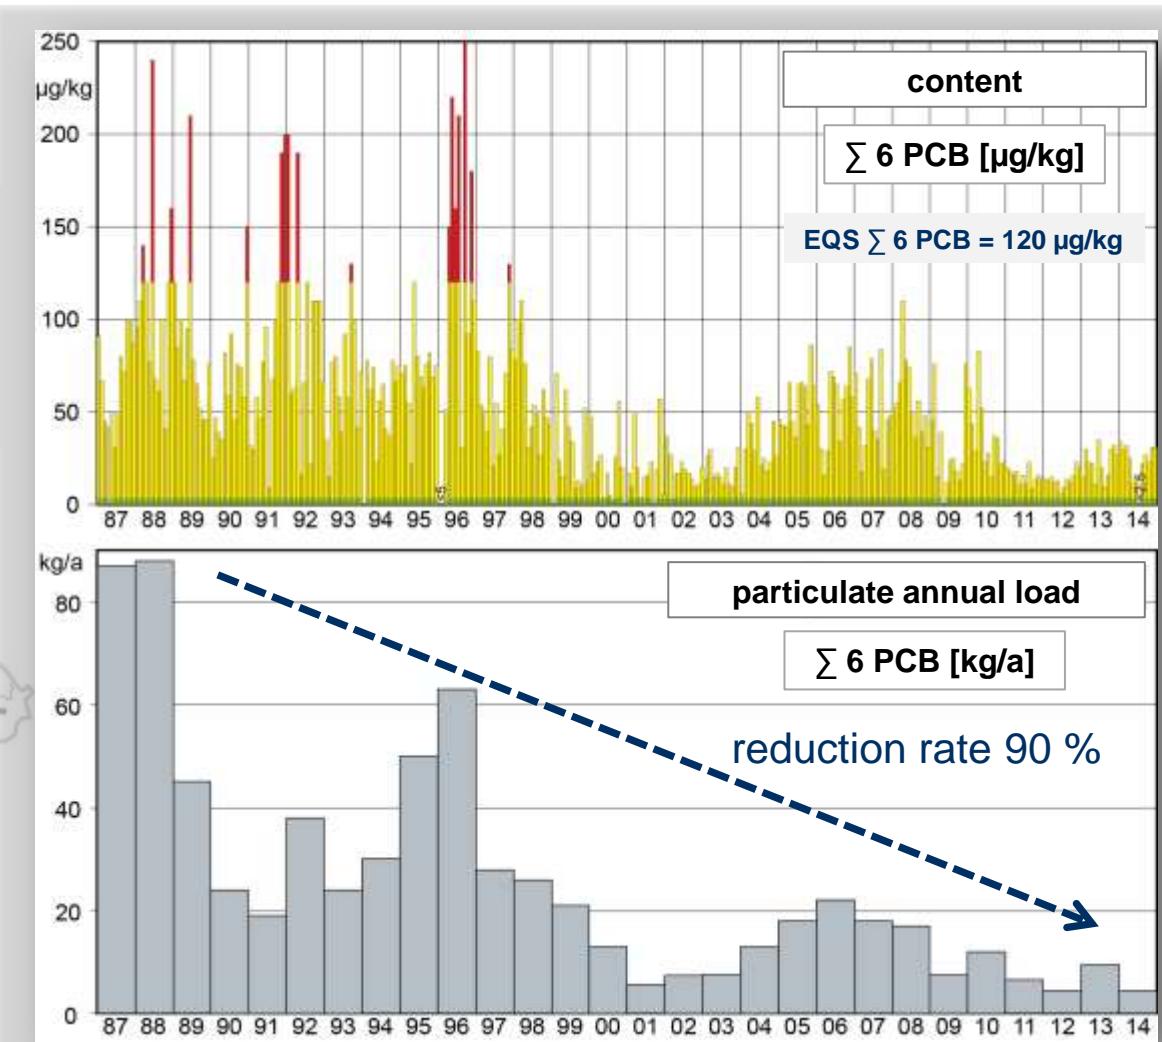
Monitoring station „Schnackenburg“  
(German navigation 474.5)

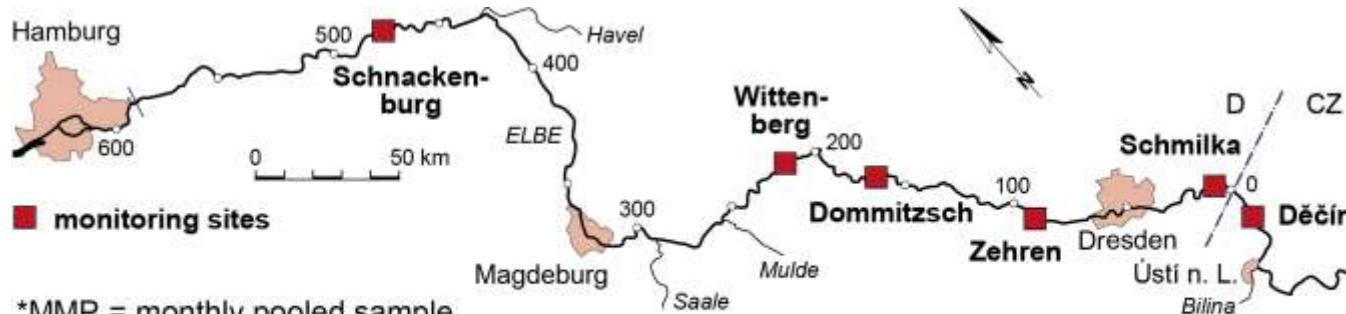
$\mu\text{g}/\text{kg}$ MMP*	NI Schnacken- burg	ST Wittenberg	SN Dommitzsch	SN Zehren	SN Schmilka	CZ Děčín
Jan.	34	51	65	112	87	178
Febr.	41	62	81	107	289	68
March	46	85	173	430	662	204
April	57	337	372	709	1.600	1.710
May	103	479	741	1.620	6.010	3.730
June	54	459	697	1.130	1.840	3.600
July	103	386	518	771	1.080	1.450
Aug.	58	322	464	497	1.090	1.440
Sept.	90	354	331	467	666	1.260
Oct.	65	453	381	525	541	1.410
Nov.	73	478	233	331	512	1.480
Dec.	118	439	344	535	1.140	1.990

highest ever measured value at an Elbe-measuring station!

EQS  $\sum 6 \text{ PCB}$ :  
120  $\mu\text{g}/\text{kg}$

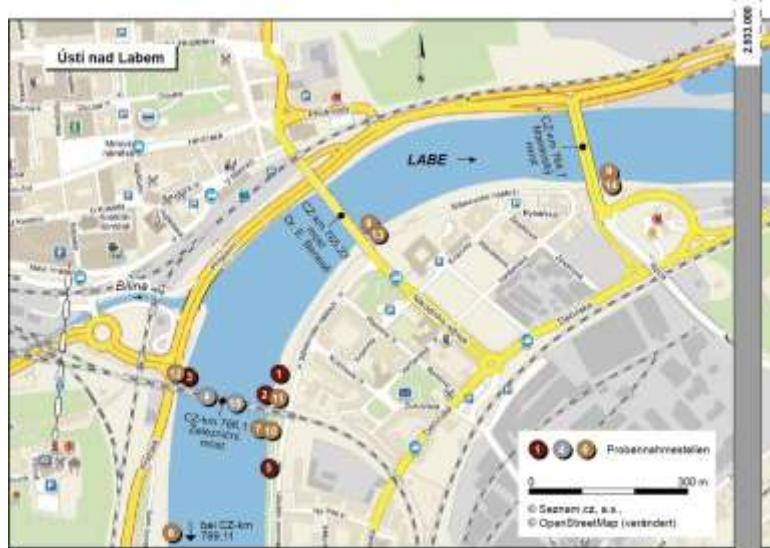
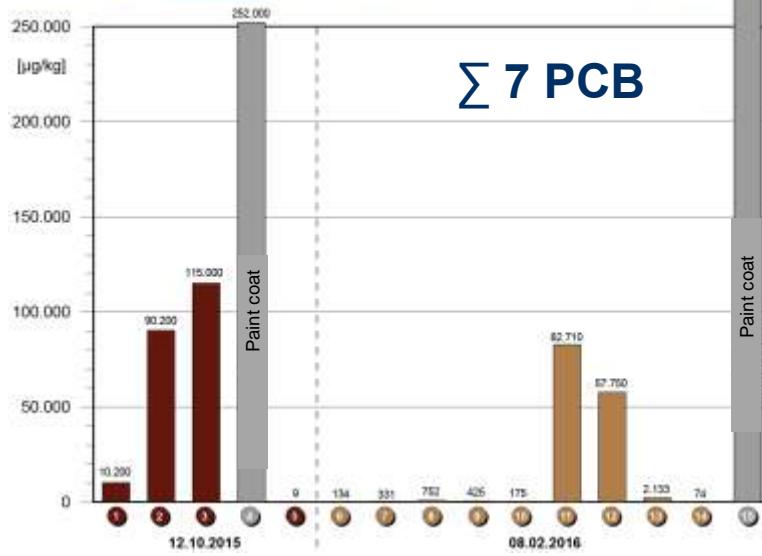
# PCB-release in Ústí nad Labem (CZ)

- ▶ causation: inappropriate removal of pcb-containing paint from a railway bridge in Ústí nad Labem
- ▶ In spite of the enclosure, release of a relevant proportion of pcb-contaminated grit into the river
- ▶ The initial paint was produced in the 1960ies and contains  $\sum 7 \text{ PCB}$  of 2,933,000  $\mu\text{g}/\text{kg}$  (equals to 0.3%  $\sum 7 \text{ PCB}$ ; resp. 1 % total PCB)
- ▶ high PCB-contamination of river sediments and floodplain soils nearby the reconstructed bridge were detected
- ▶ objection by the polluter delays the environmental remediation

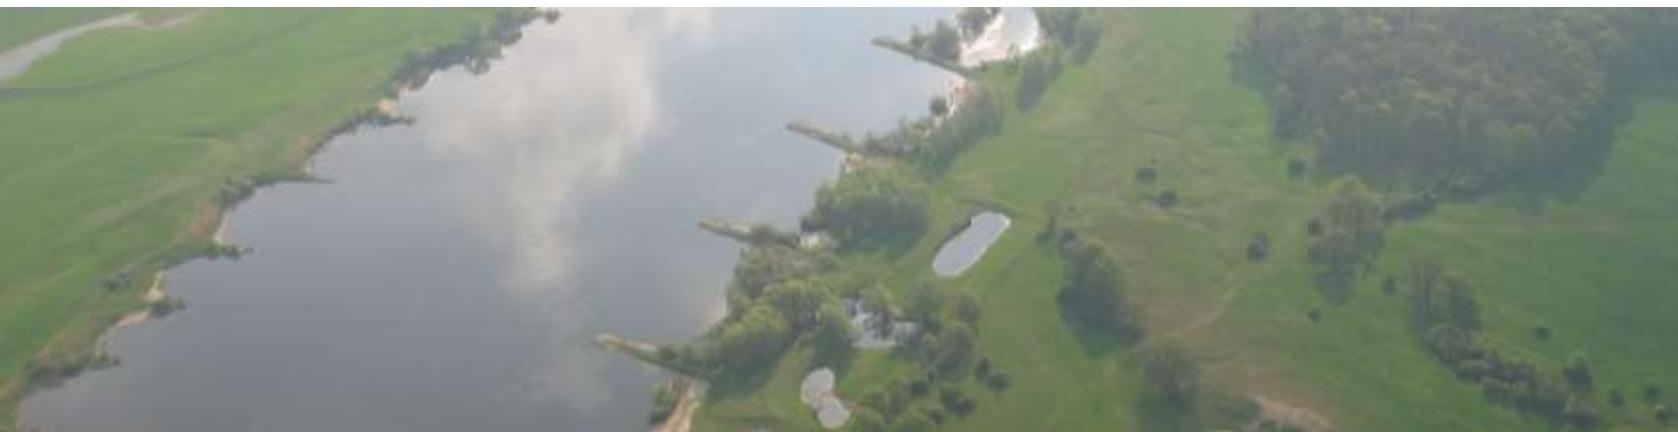
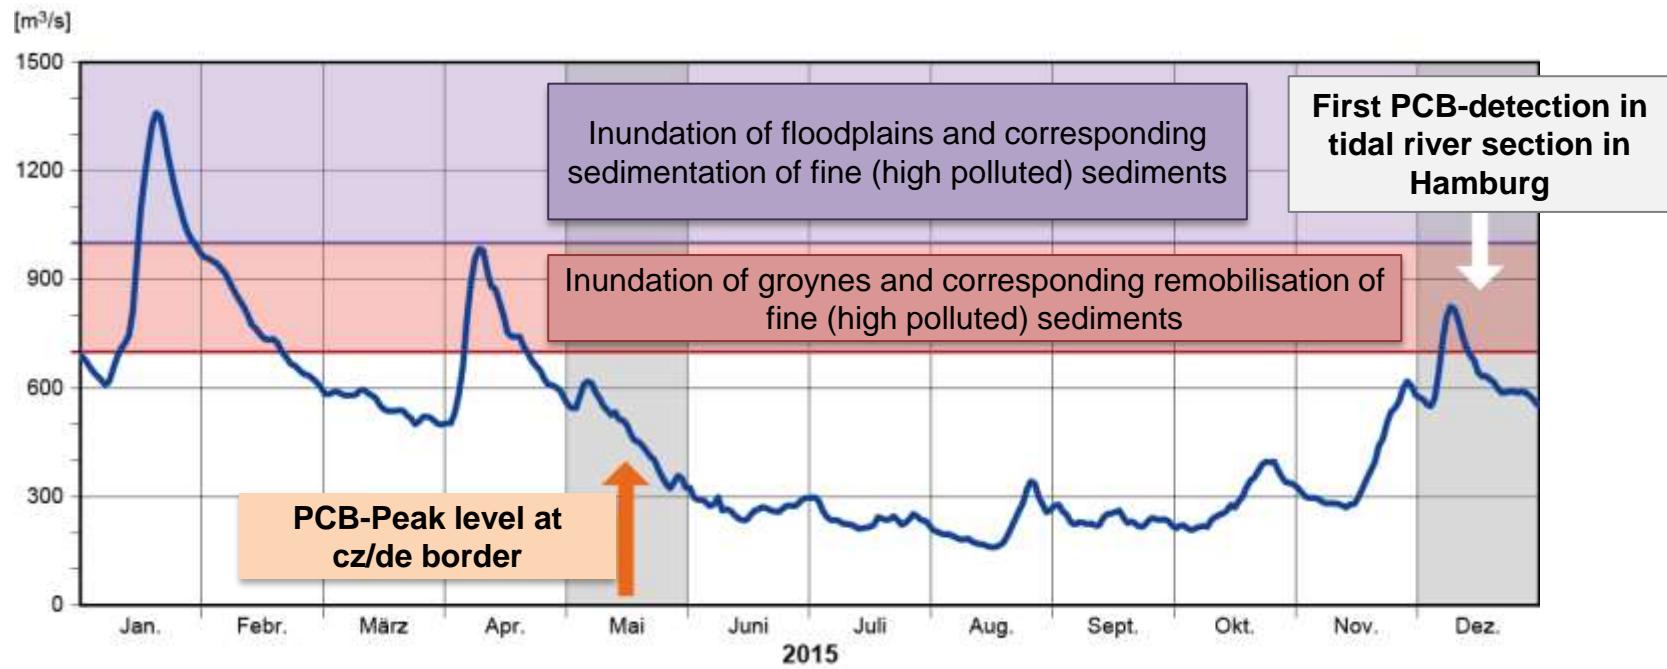
# Headwater discharge and implications to contaminant transport

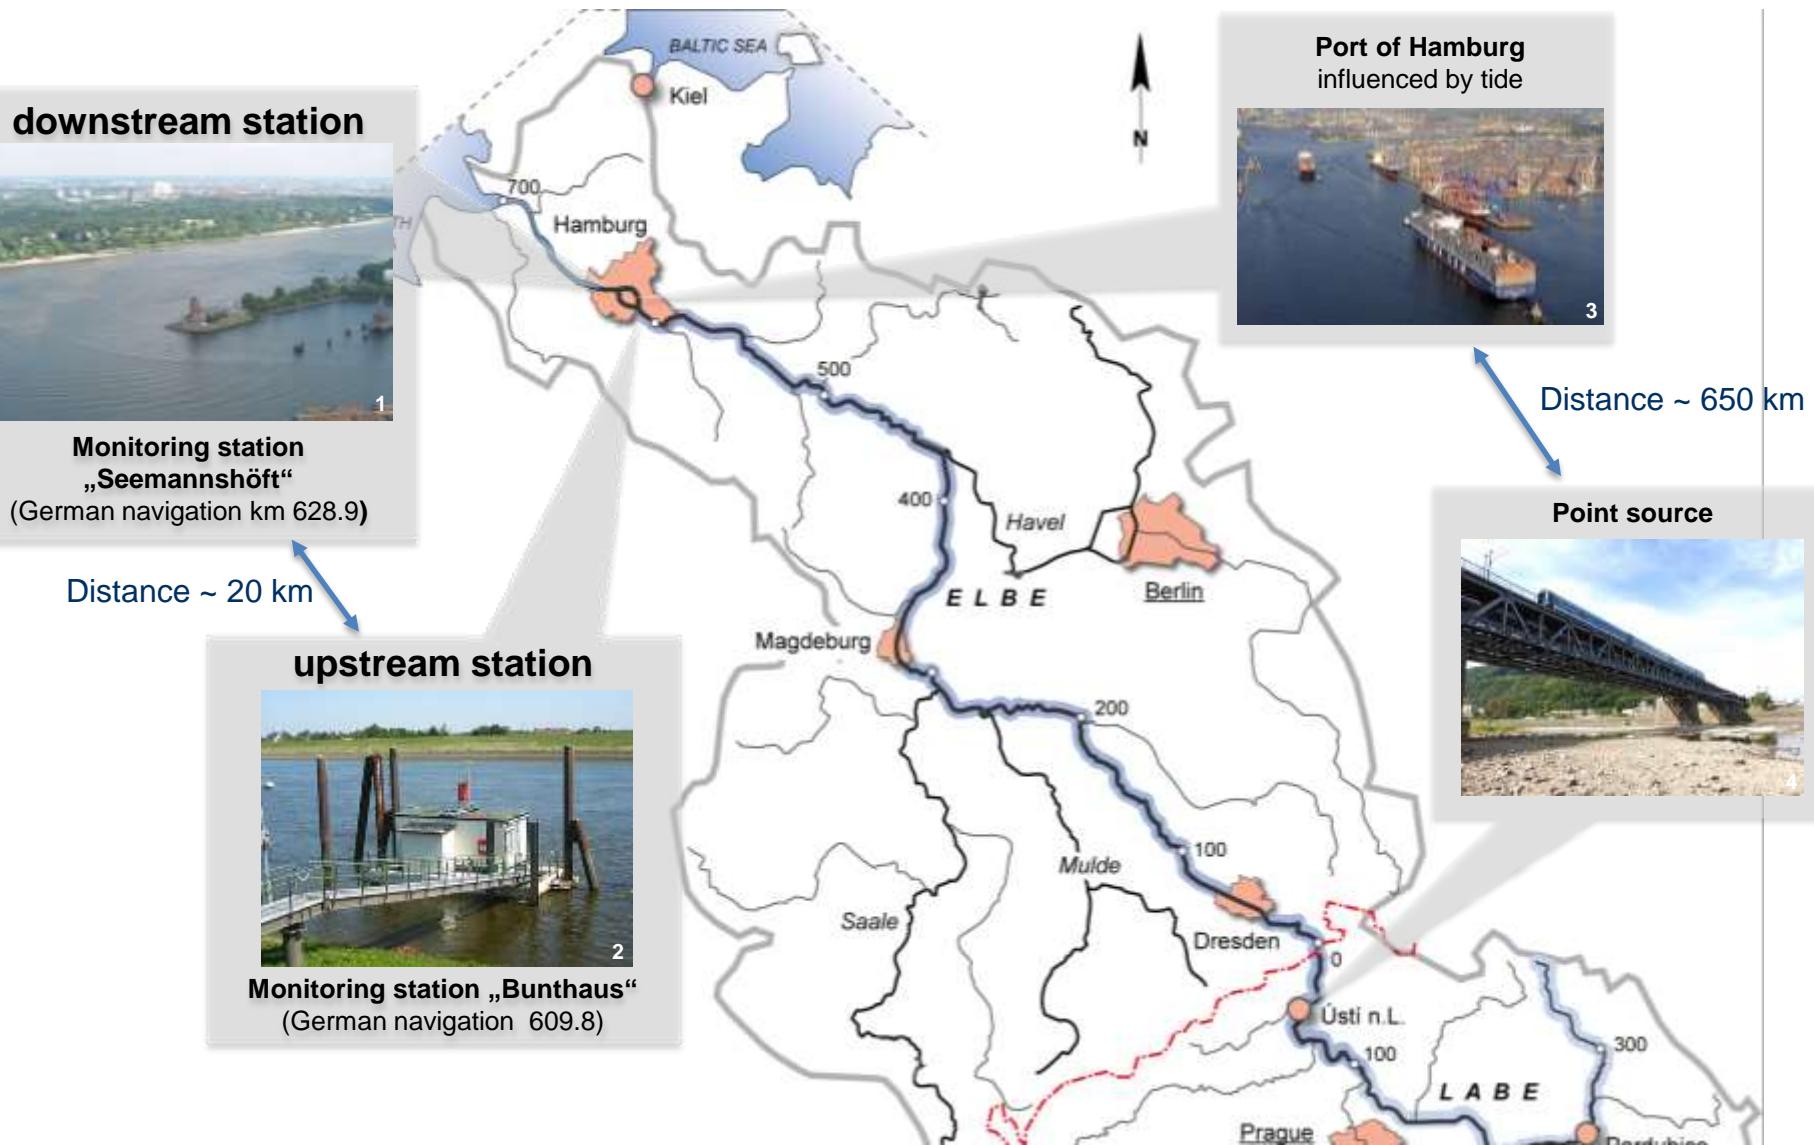
# Input- & output- signal

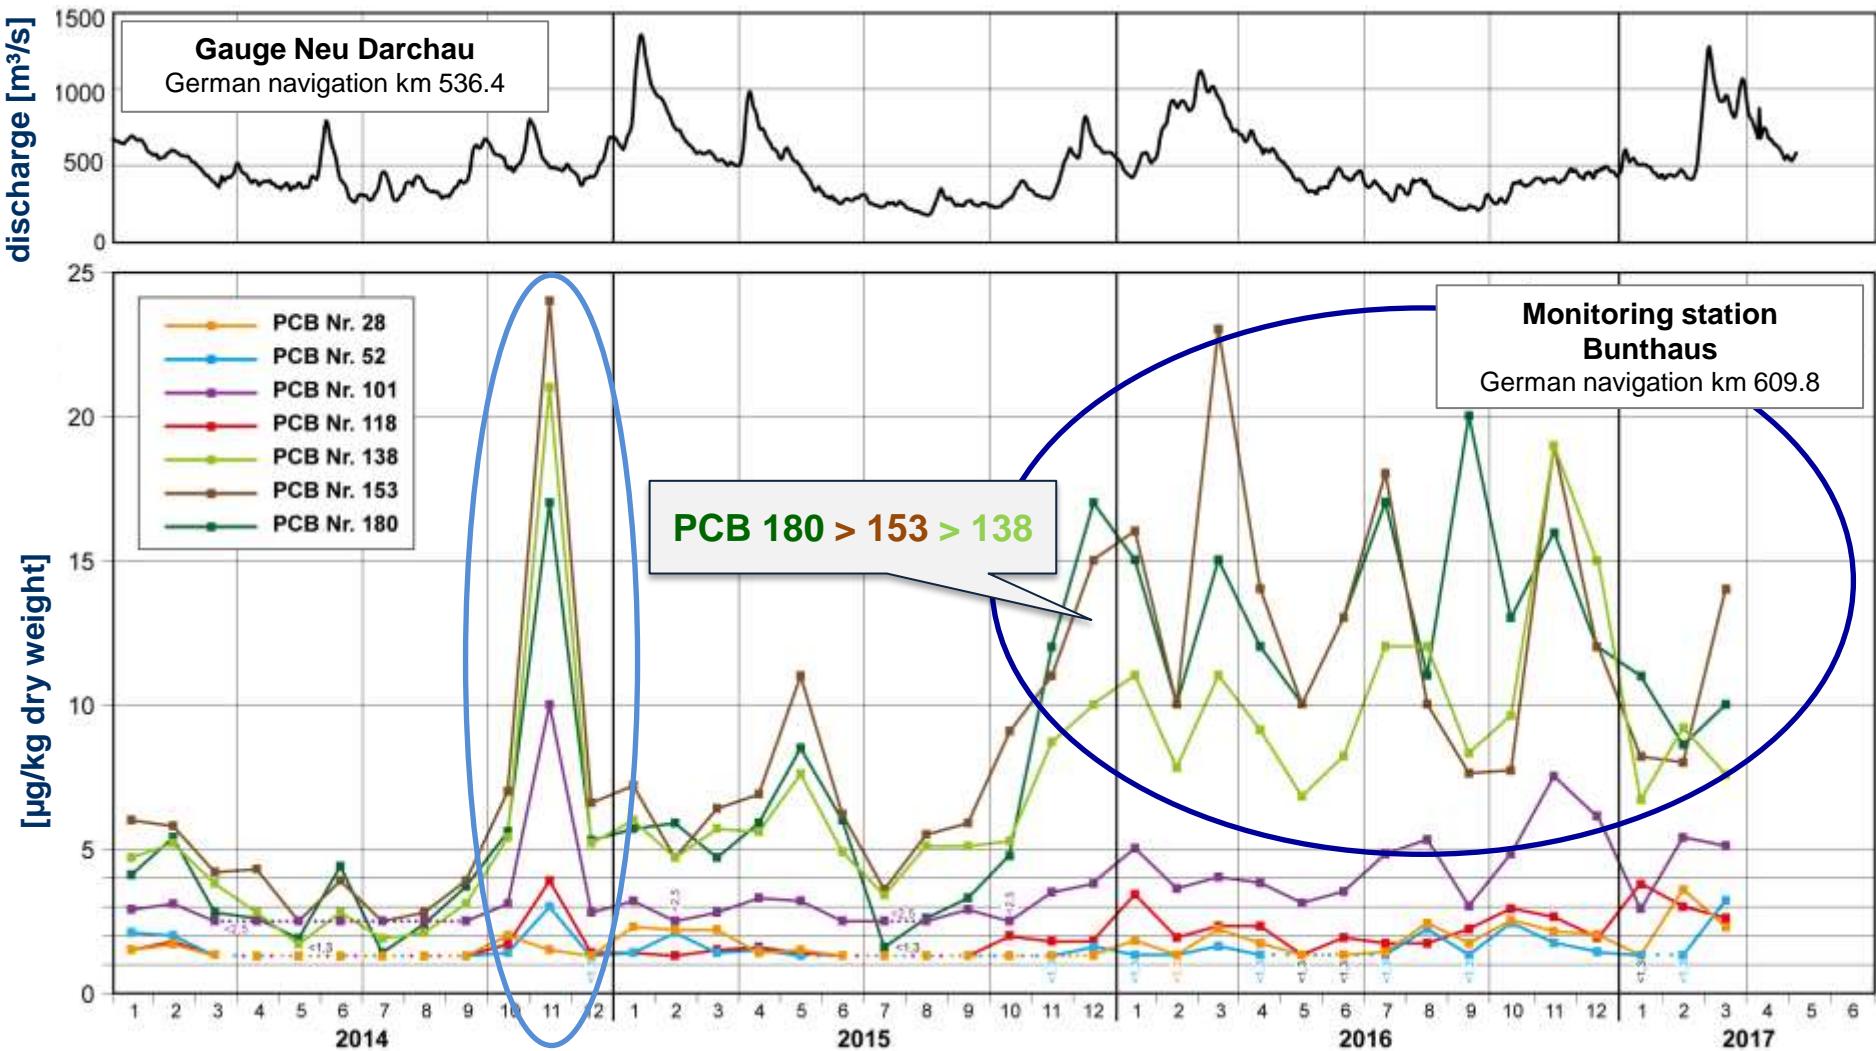
# Upstream monitoring station

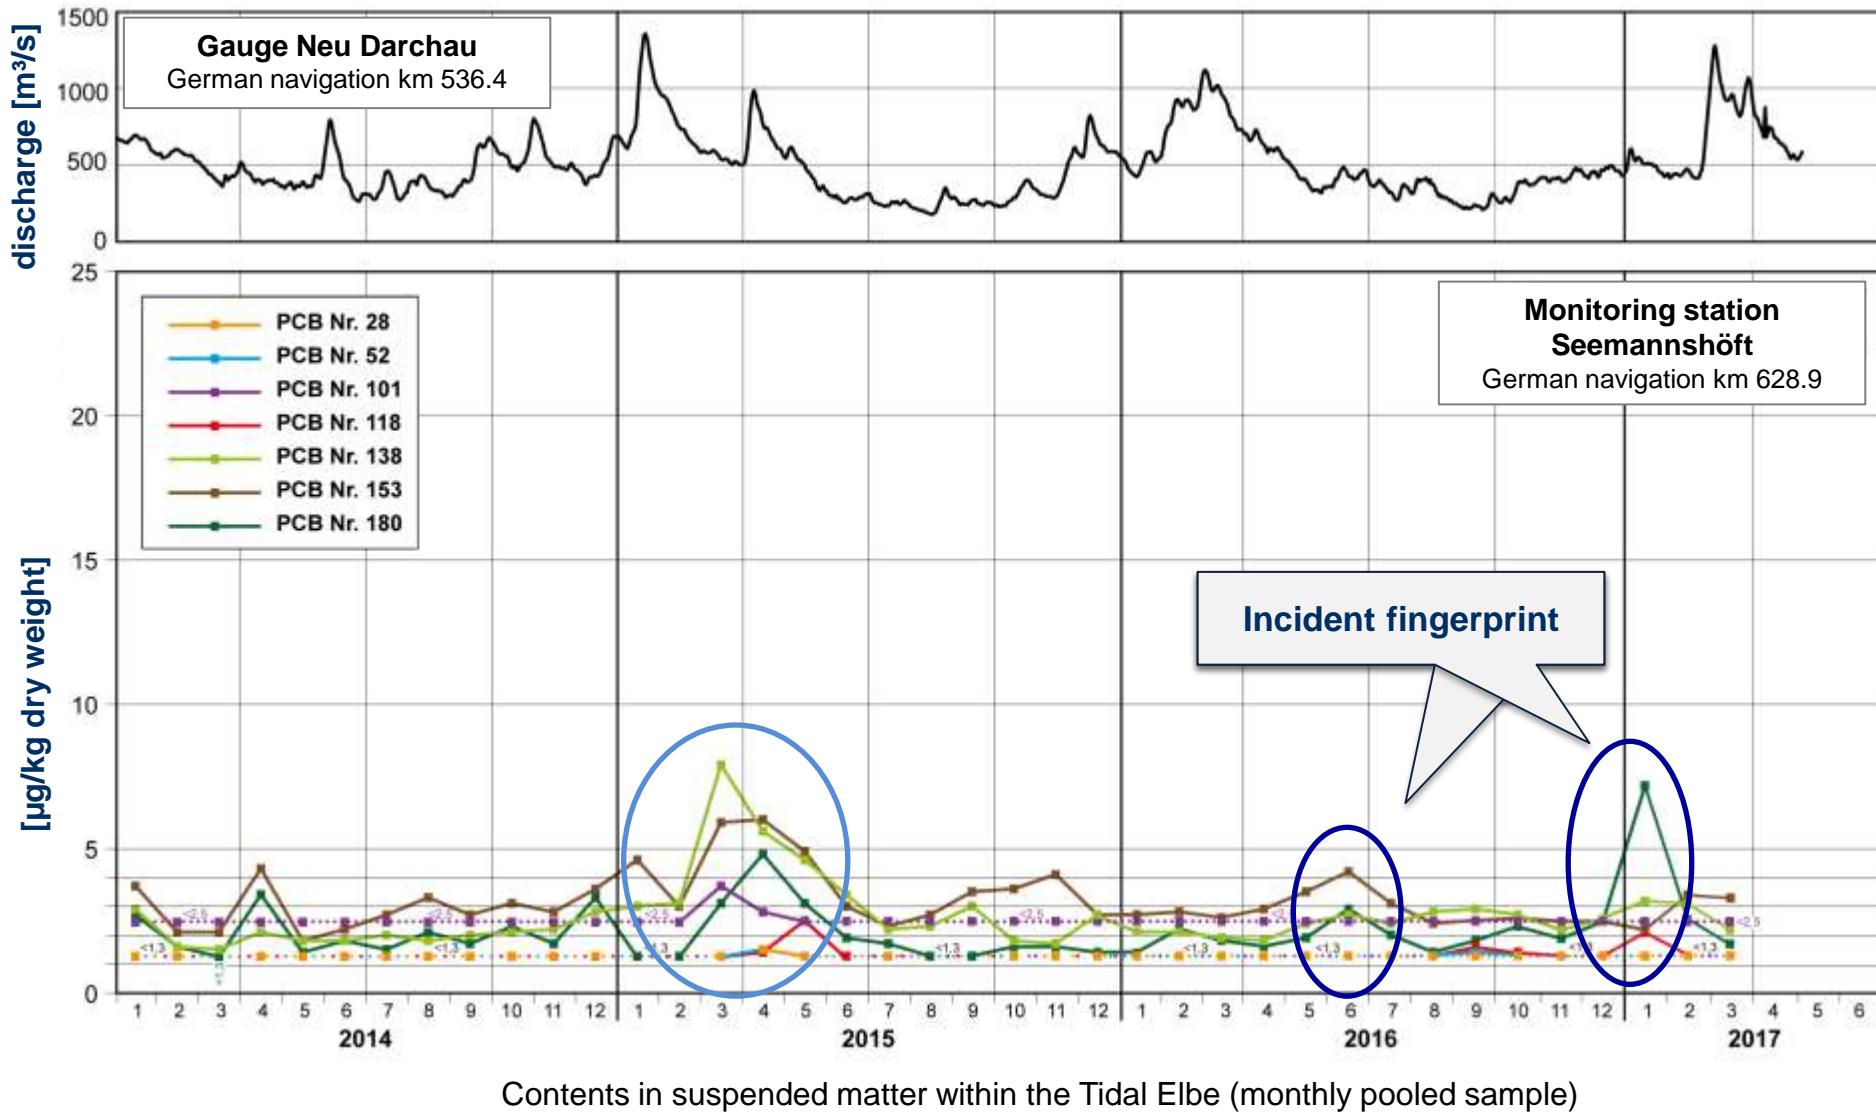
# Downstream monitoring station

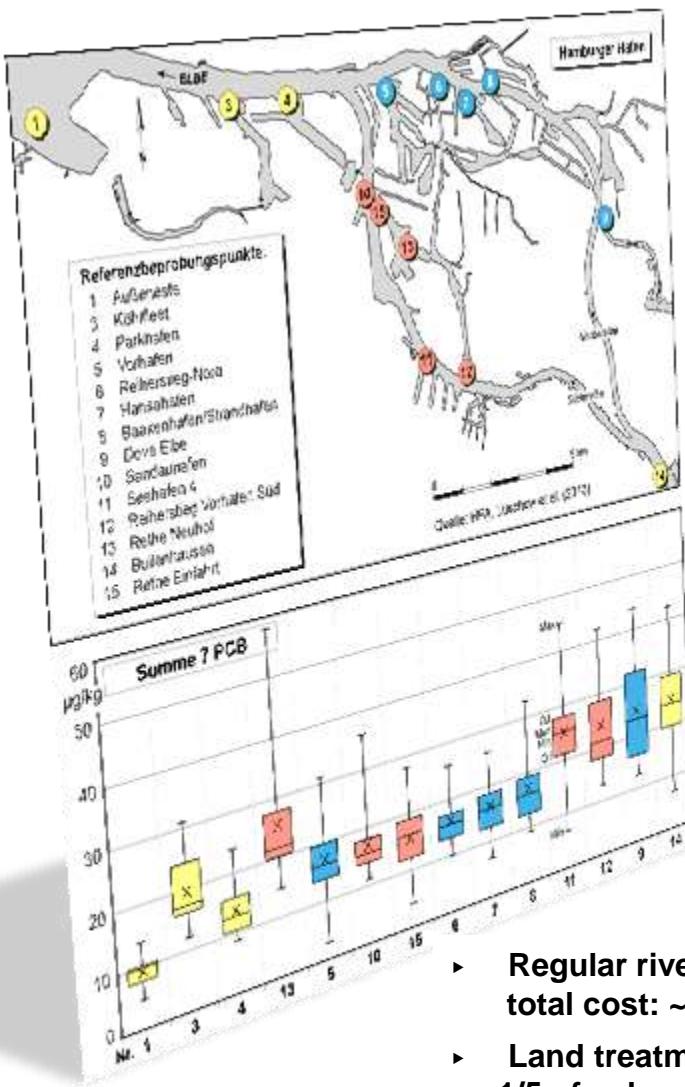
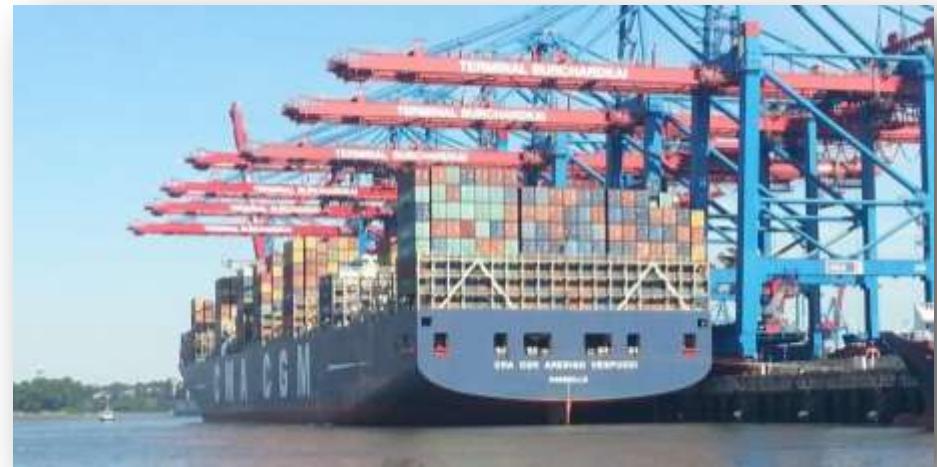
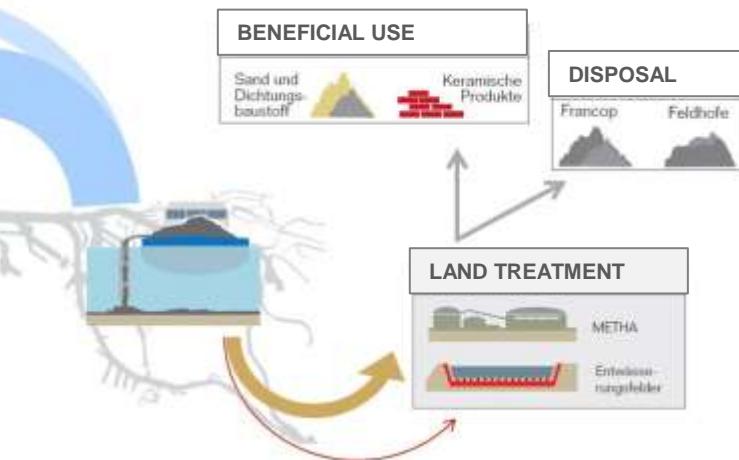
# Dredged material management concept (Port of Hamburg)

low contamination

1 - 3 Mio.  $\text{m}^3/\text{a}$

4 - 8 Mio.  $\text{m}^3/\text{a}$

- ▶ Regular river maintenance  
total cost: ~ 75 Mio. € per year!
- ▶ Land treatment:  
1/5 of volume, but 3/4 of cost!

high or specific contamination:  
Land treatment & disposal  
up to 1 mio  $\text{m}^3/\text{a}$

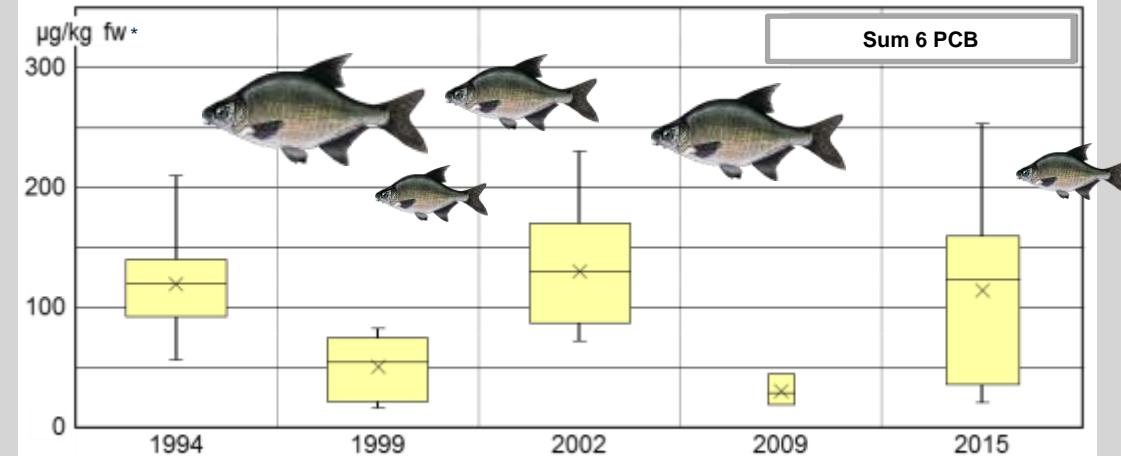
## Development of PCB-concentrations (sum 6 PCB) in fish near the German/Czech border in 1994 - 2015
