# Sediment management in Lake Trakošćan, Croatia - an example of the social and economic aspects of sediment long-term impacts

Dijana Oskorus<sup>1</sup>, Sanja Kapelj<sup>1</sup>, Karlo Leskovar<sup>1</sup>, Igor Tošić<sup>2</sup>

<sup>1</sup>University of Zagreb, Faculty of Geotechnical Engineering, Hallerova al. 7, 42000 Varaždin, Croatia

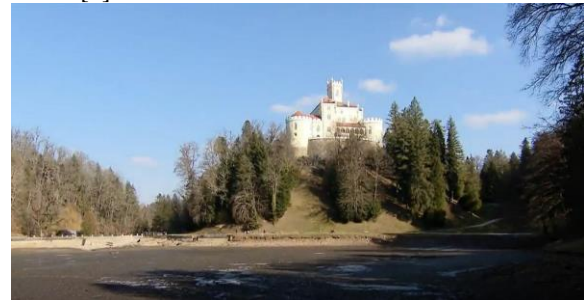
Fig. 2: Drained Lake Trakošćan
