Capping of contaminated seabed in Norway – lessons learned

Jens Laugesen, DNV GL, Høvik, Norway

Espen Eek, NGI, Oslo, Norway

14.06.2017

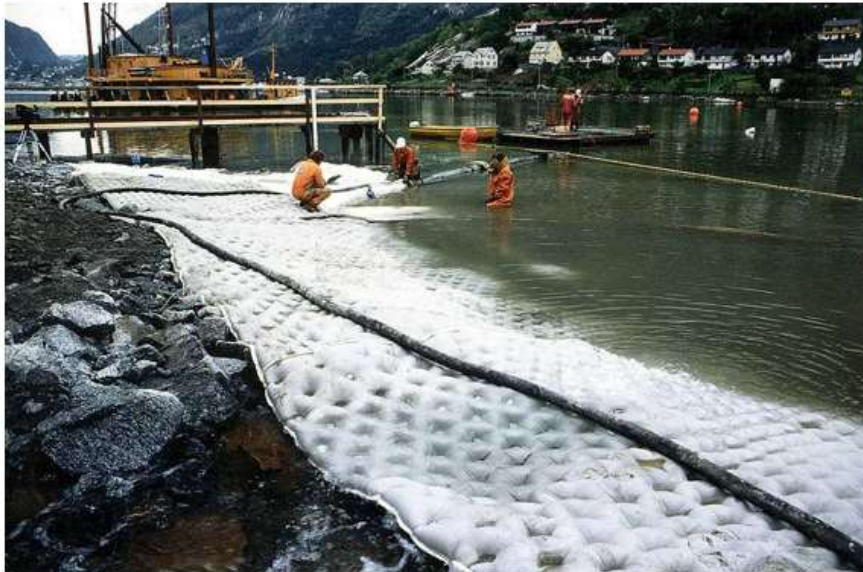
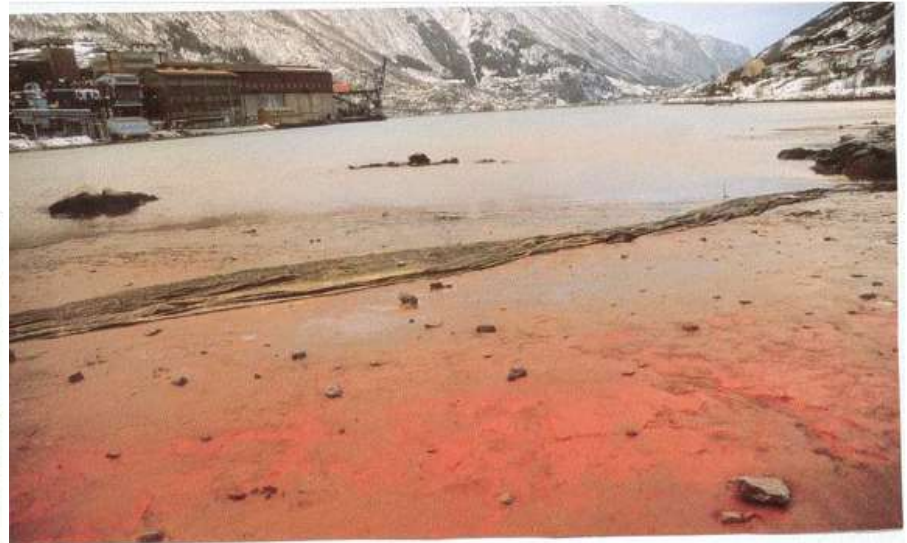
Eitrheim Bay Project 1991 - 1992:

- In Norway the first capping project was performed in the Eitrheim Bay in Sørfjorden in 1992.

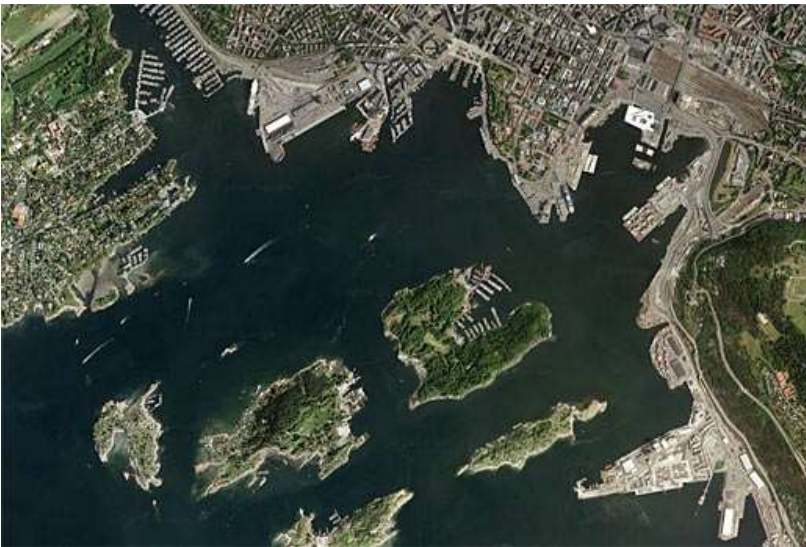
Oslo harbour where about 1 km² has been capped. (www.dykking.no)
