Schadstoffsanierung Elbsedimente

Side Structures along the Elbe - the local and regional risk from sediments -

Susanne Heise

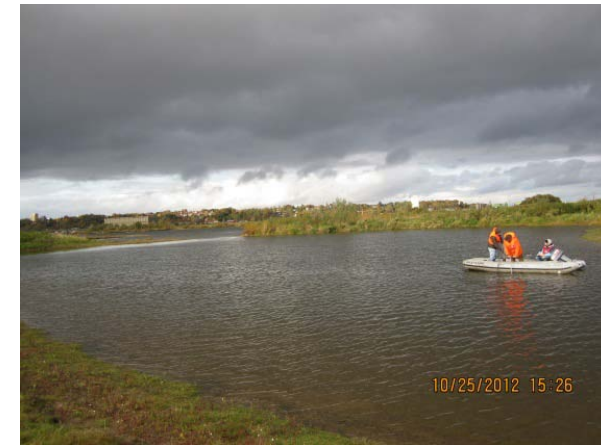
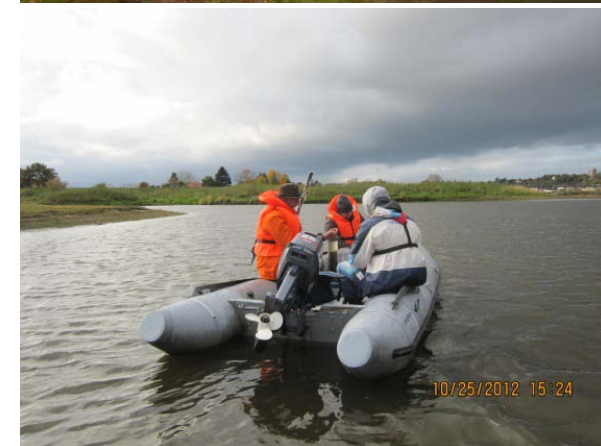
Lage der Probenahmeareale im Elbeinzugsgebiet

Elbe-km 340 - 569

15 side structures in 7 areas,
on average 2 side-structures sampled per area
2 – 3 locations per side structure

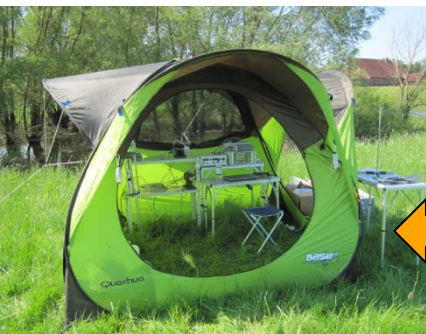
On site measurement of erosion stability

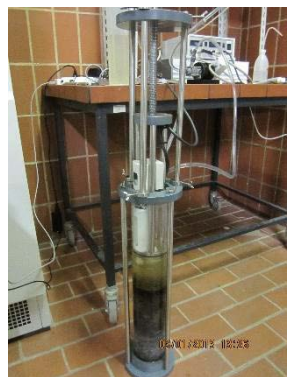
Transport to the lab to determine mass erosion at high shear stress (worst case)

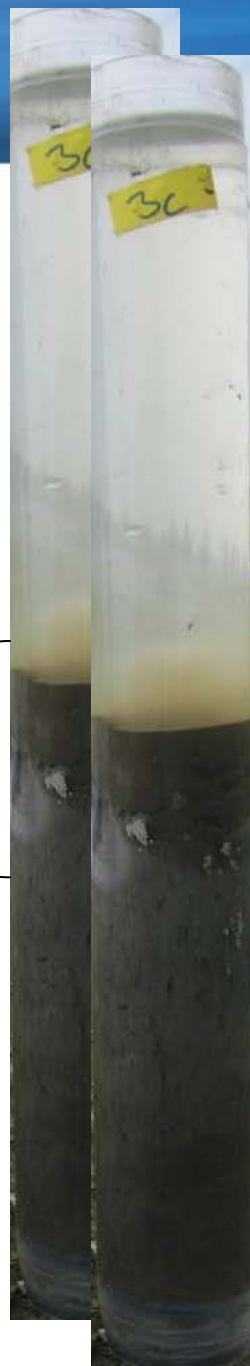
Fluffy layer
0-1,5
3-4,5
6-7,5
9-10,5

0-10 cm Analysis of historic substances (HM, HCB, PAH, PCB)
10-20 cm

Deep sample with peat corer

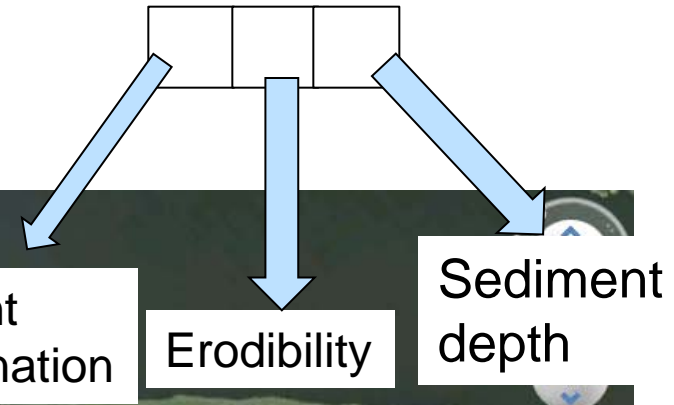
Visualization of results: Side structure at Grippel

Sediment depth	SKT	LBT	AGI
0-10 cm	-16,9	21,86	-28,77
10-20 cm	74,97	32,13	-62,68
>20 cm	56,94	30,81	15,81

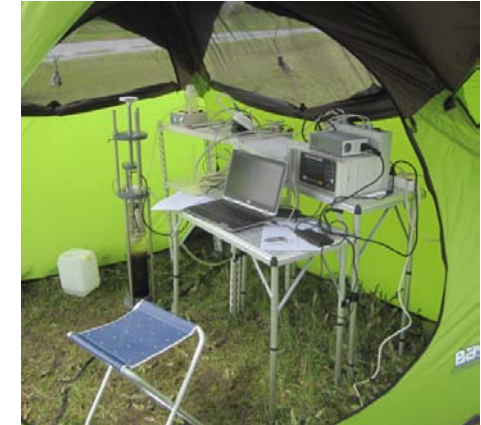
Mobile microcosm set up

Principle:
stepwise increase of shear stress,
Monitoring of turbidity
