**Design and implementation of an** erosion protection barrier for mercury-contaminated sediments at **Tollare, Sweden Andrew Petsonk** WSP Environmental, Stockholm, Sweden Jonas Jonsson WSP Civils, Stockholm, Sweden Fredrick Marelius Royal Institute of Technology, Stockholm, Sweden

2008-05-27 Petsonk – Design and implementation of an erosion protection barrier at Tollare, Sweden

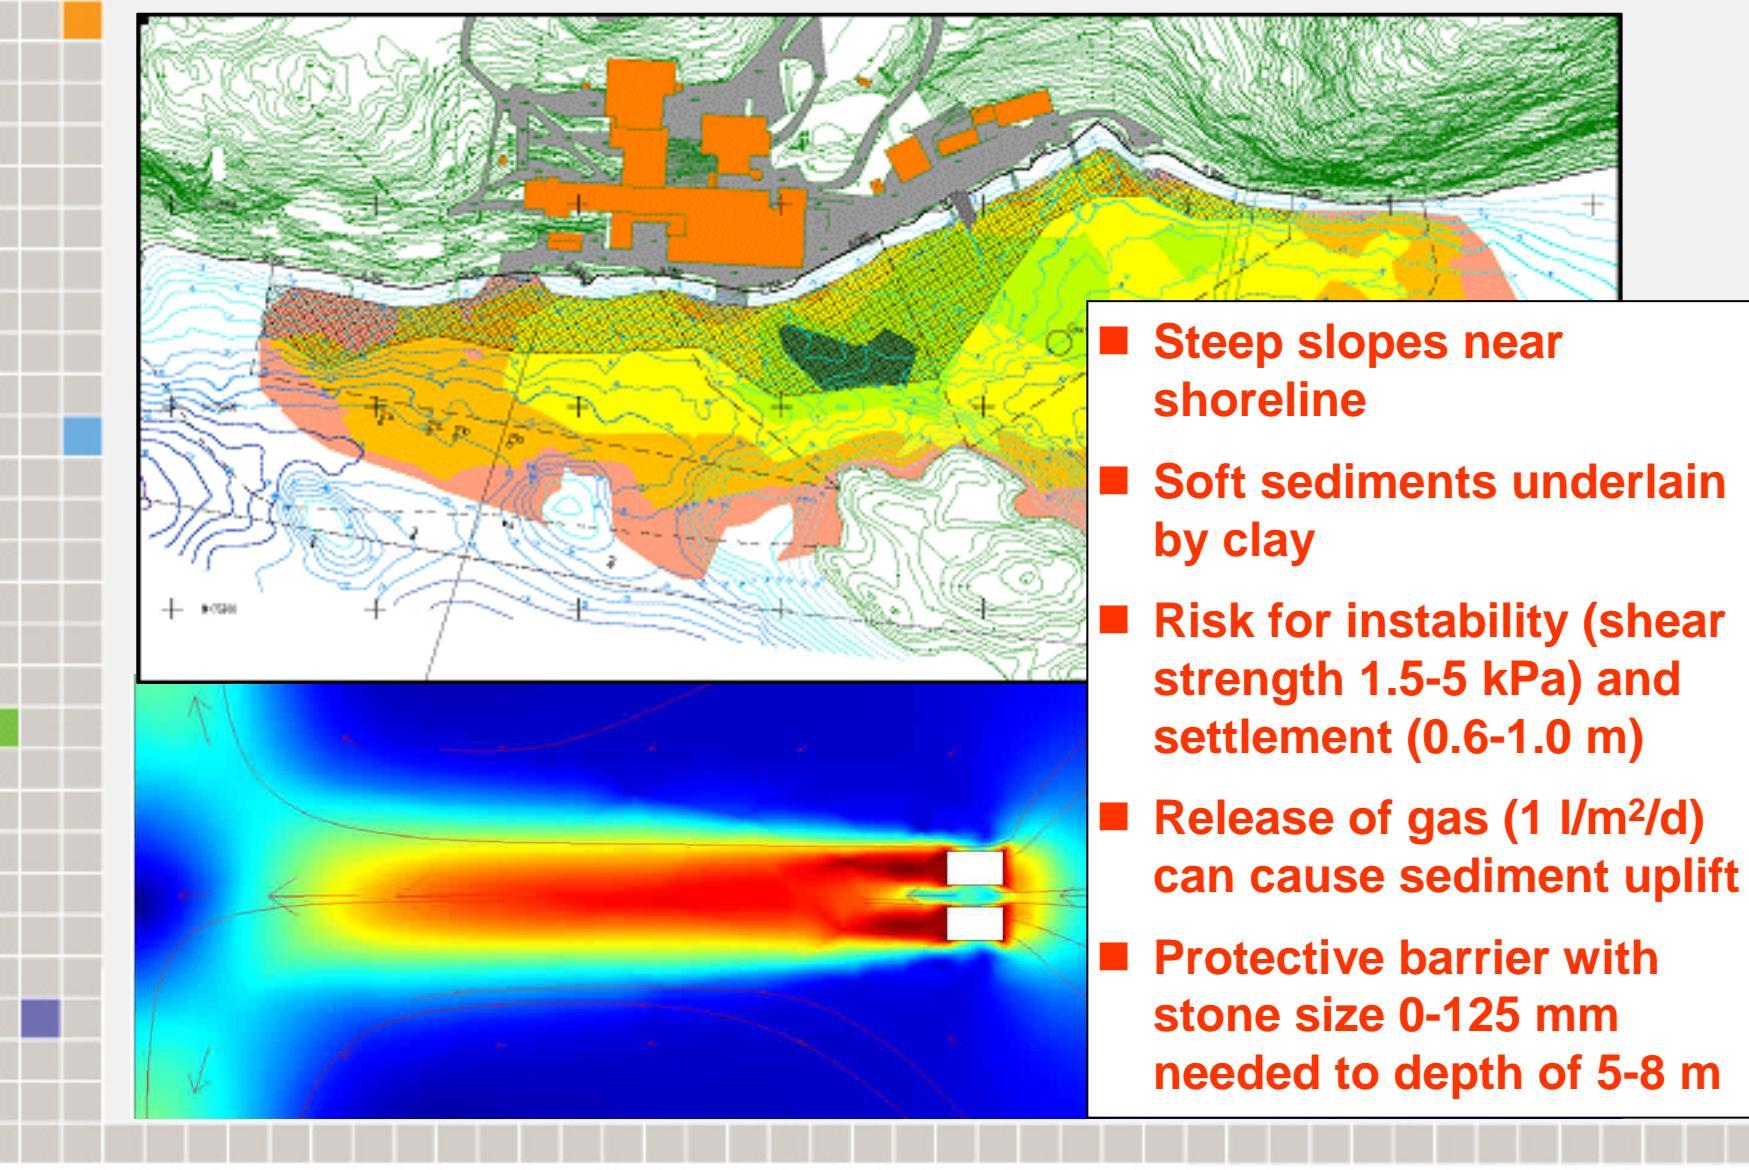
## **Preliminary design, permitting**

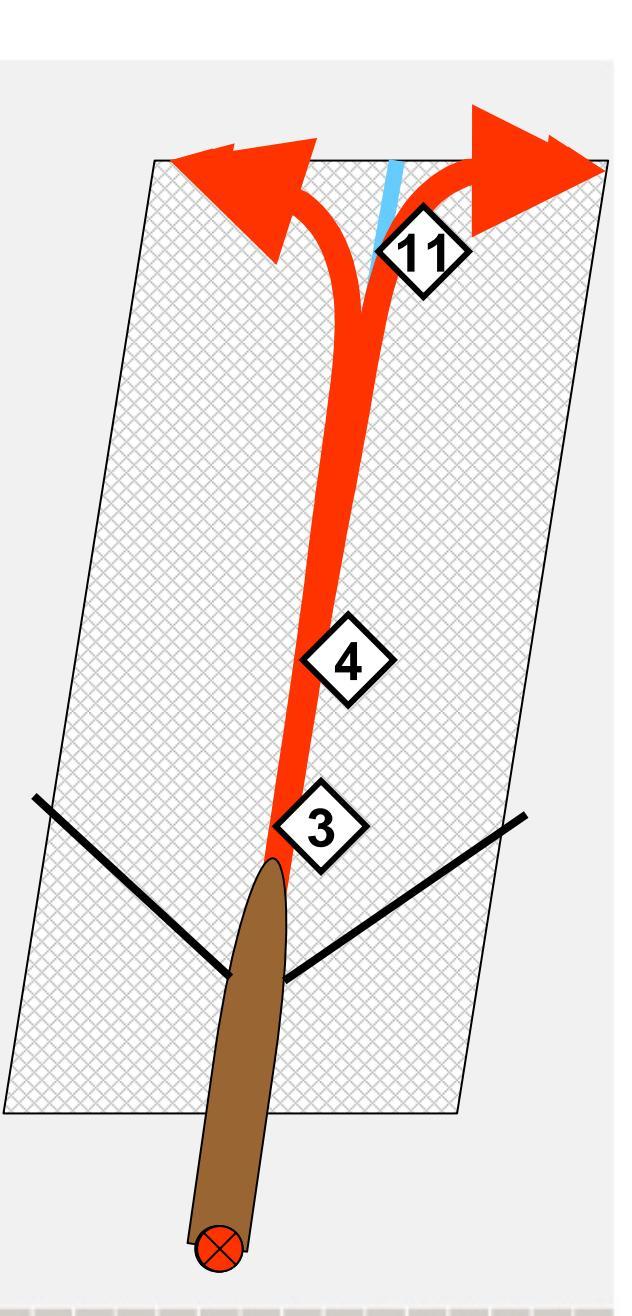
# **Erosion test**

#### 12 m long boat

- 200 horsepower engine, max 1800 rpm
- Propeller diameter 0.95 m, max depth 1.6 m

#### Labelled observation points

Three succesive test phases

Rpm	Time (min)
700	6
1200	2
1700	2
	Rpm70012001700

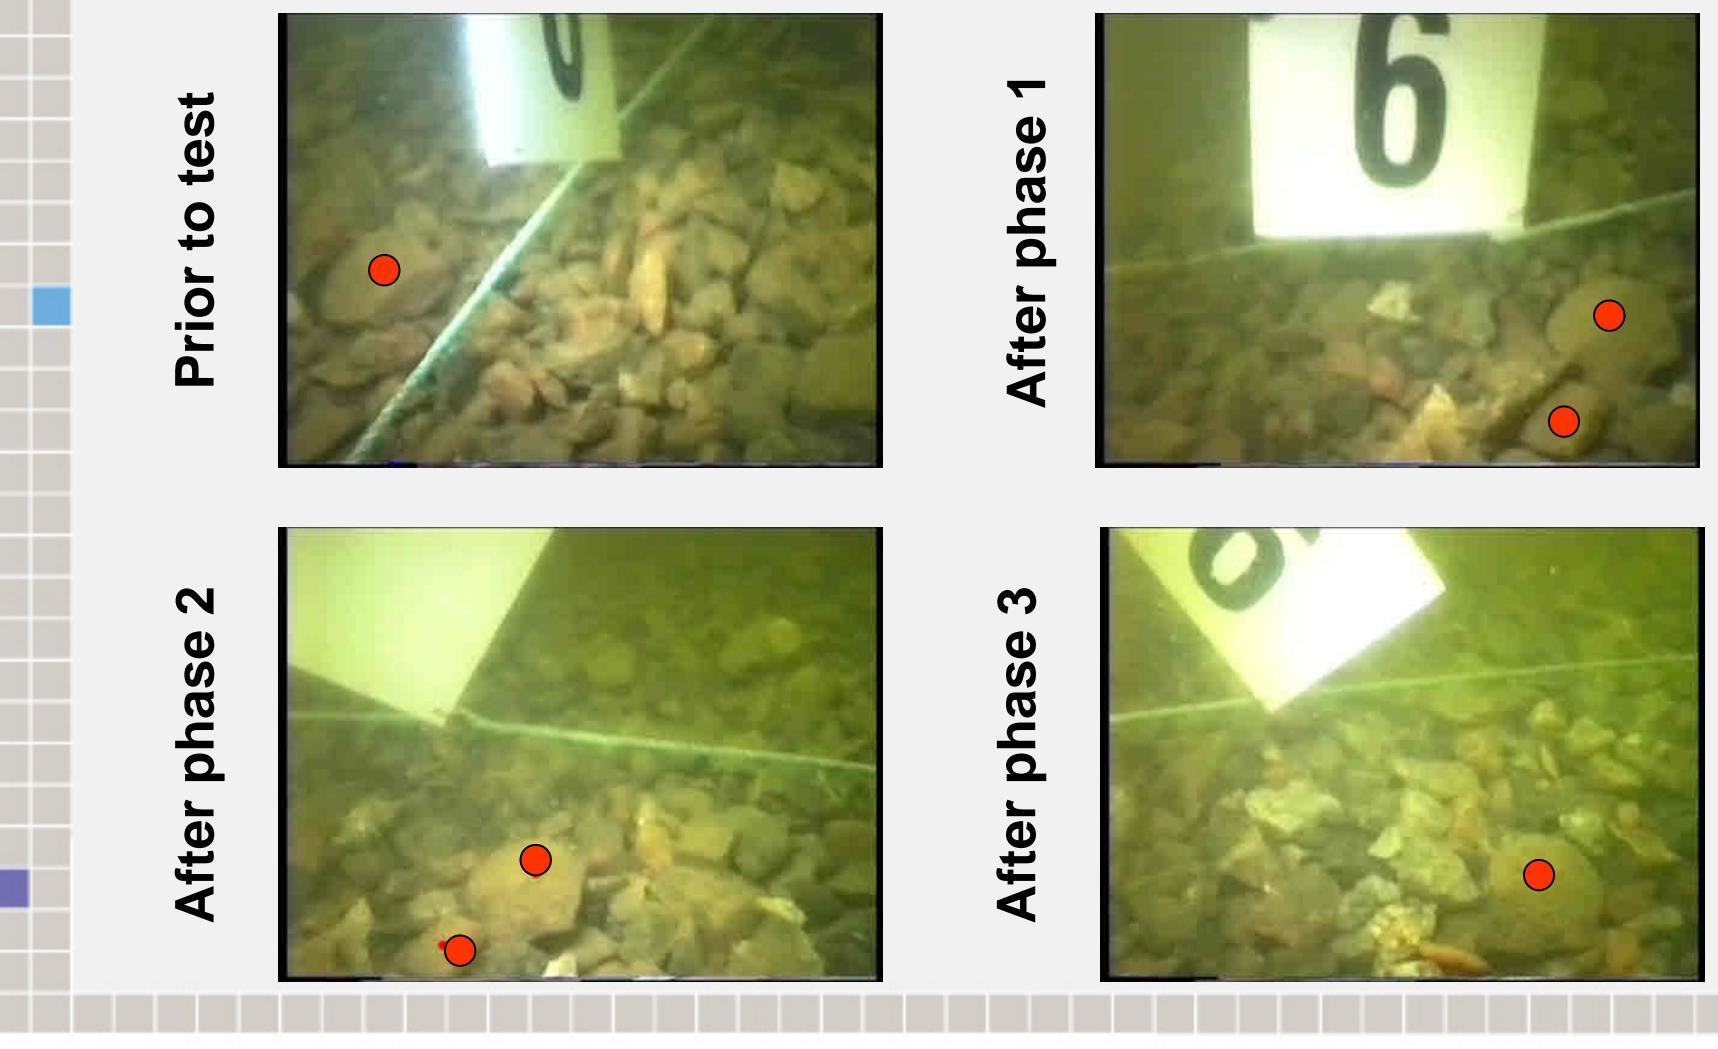
# **Results from erosion test**Label 6 located 12 m from the propeller

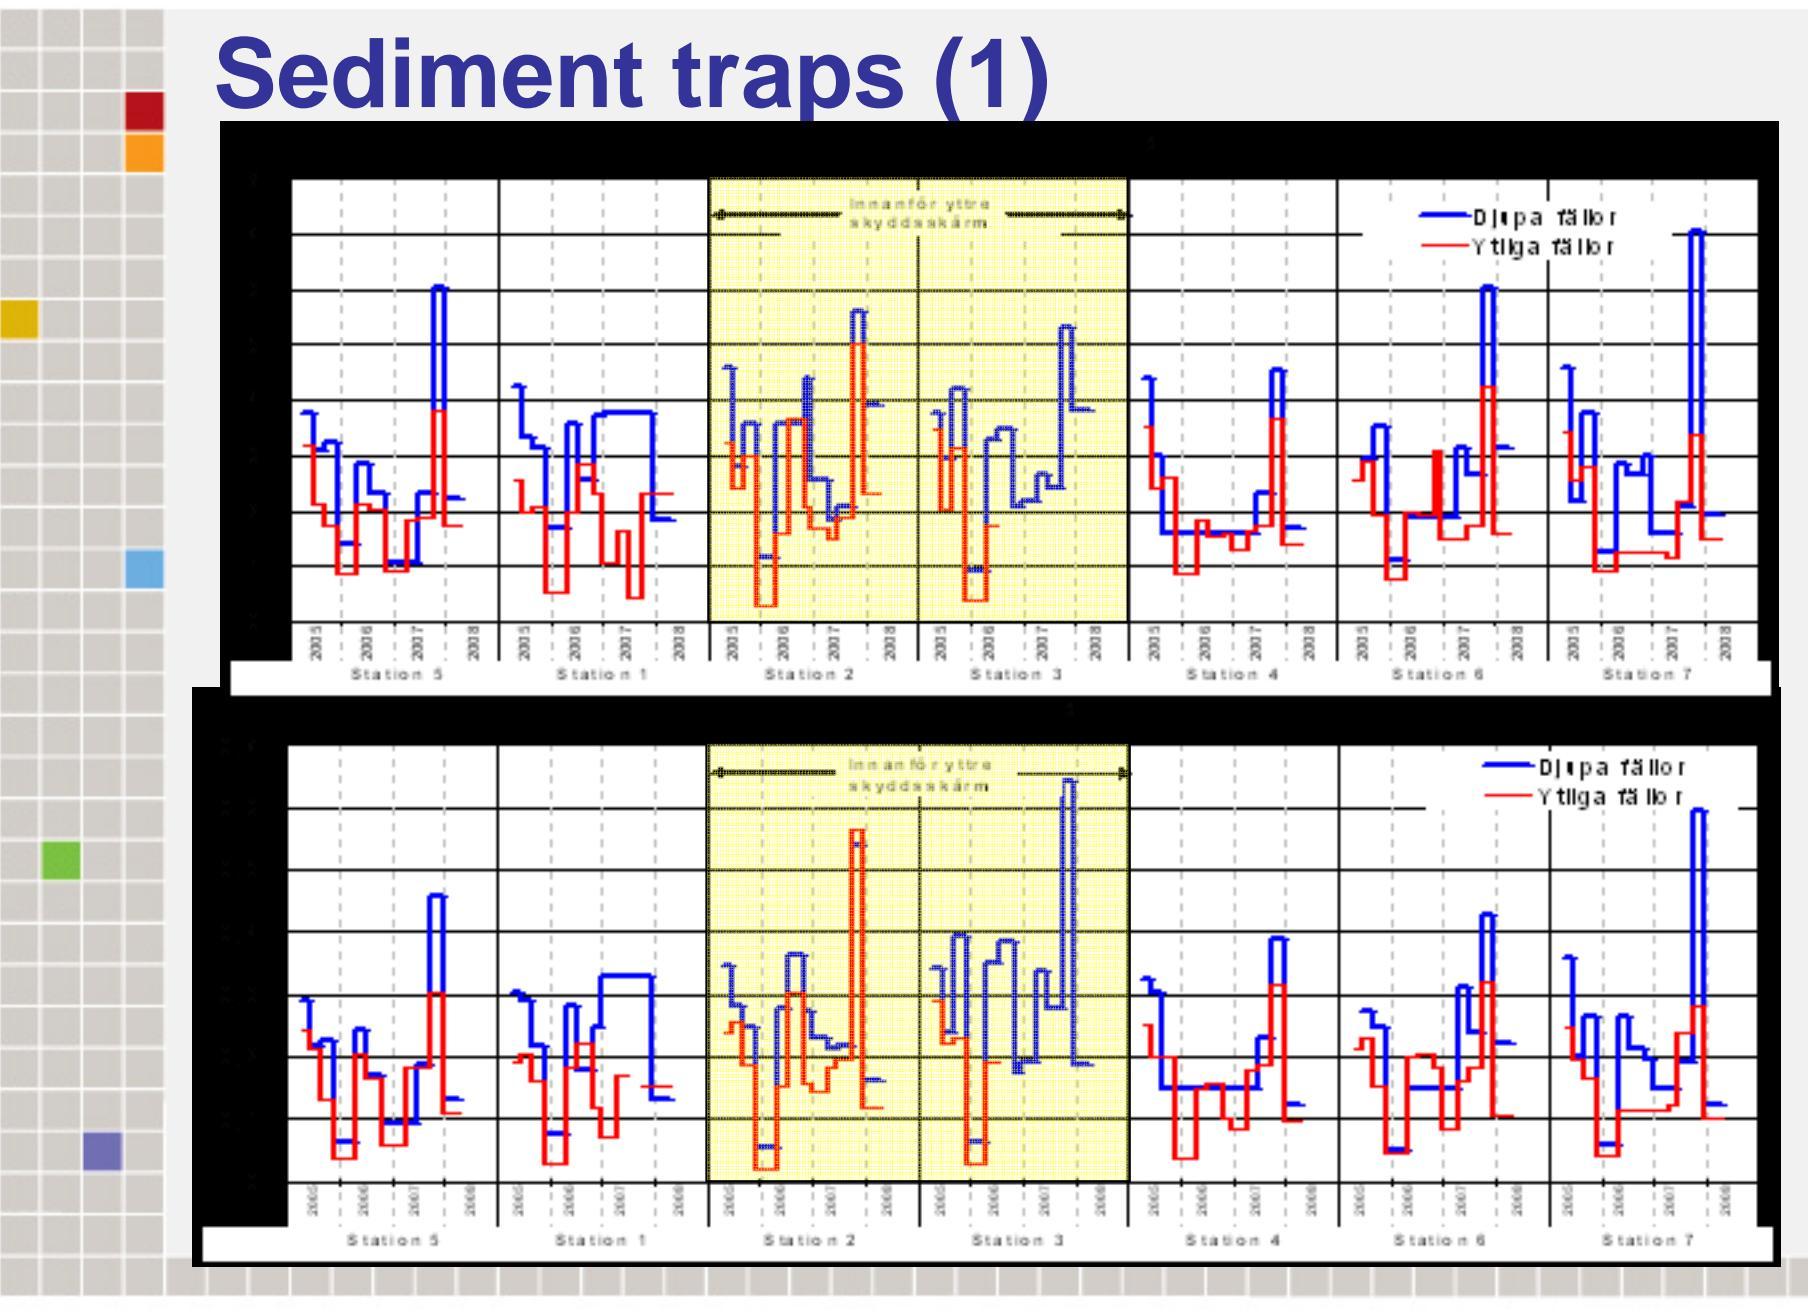
# Monitoring

- Barrier thickness
- Settlement and movements
- Turbidity in 4 zones
  - Inside inner screen
  - Between inner and outer screens
  - Outside outer screen
  - Reference stations
- Sediment traps
- Water sampling
- Ocular observations
