Sediment characteristics after treatment with dewatering tubes

Markus Wilke¹, Bernd Thesseling¹

¹HUESKER Sythetic GmbH, Fabrikstrasse 13-15, City, Germany

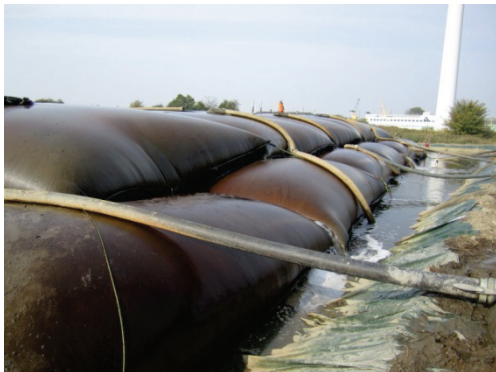
Fig. 1: Installed tubes in a pyramidal pattern.

As the tubes can be installed in a stacked pyramidal pattern with several tube layers another question raised was the undrained shear strength of the dewatered material. By using a hand-held vane tester the undrained shear strength at several locations in different tube layers was determined.

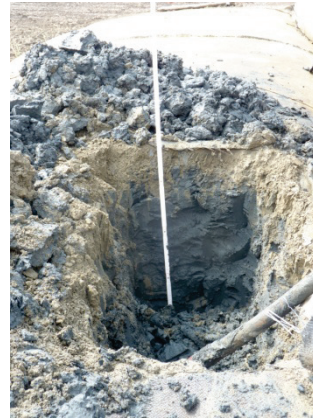
Fig. 2: Trial pit in the lower (first) tube layer.
