# Long term effect of sediment remediation - mechanisms of failure and success based on case studies

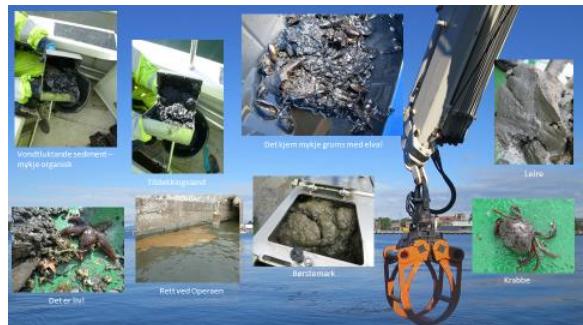
**Fig. 1:** Long term effect of the remediation of Oslo harbor, documented by field observations.

Oslo harbor: the observed long term recontamination caused by urban runoff and river transport to the remediated area. Based on time series of monitoring data since the project was finished in 2009.
